TIGER® Diagnostic Report

***Diagnostic Analysis Report
for
GE Frame 7 Gas Turbine
at
Power Plant***

EXECUTIVE SUMMARY

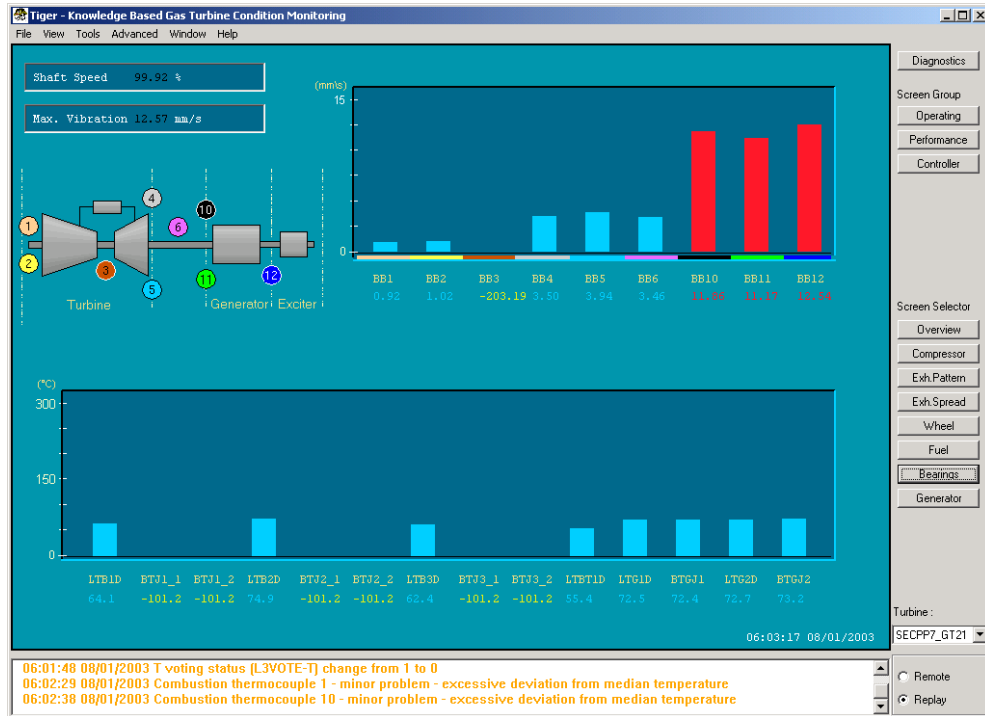
Bearing screen with failed bearing vibration transducer 3 (BB3) indicated.

This bearing transducer has failed. The fault could be due to a mounting problem, bad wiring, plug fallen out etc.

Check transducer and wiring and repair at next outage. If possible, disconnect the transducer until it is repaired, to avoid the possibility of spurious signals causing a vibration trip.

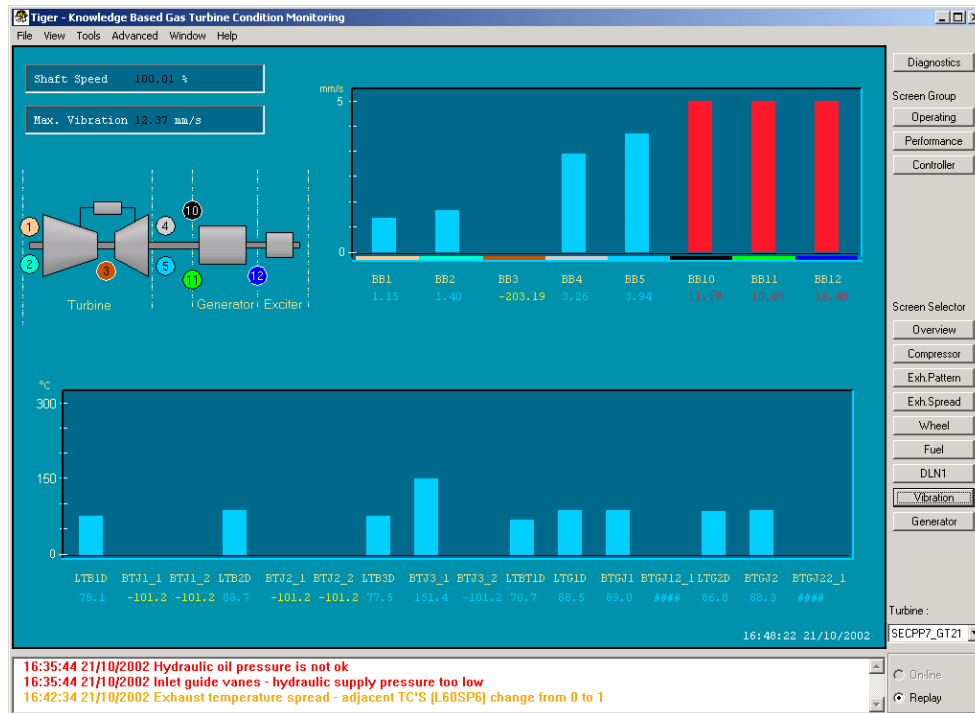
The vibration screen indicates that the generator bearings BB10, 11 and 12 are indicating a high vibration level.

As all three vibrations transducers on the generator are high, this indicates that this is a real high vibration problem, and is not being caused by transducer faults.

- Loose generator rotor bars
- Cracked generator rotor end bells
- Misalignment
- Unbalance
- Too much or too little lube oil in bearings
- Journal bearing wear

If possible, examine the vibration spectrum from the generator. This can be done with a portable vibration monitoring unit. This would assist in diagnosing the causes of the high vibration.

Check the cooling of the generator and for inadequate performance of the cooling system. Check fans are all running properly and the variable temperature regulator (VTR) controlling the lube oil is functioning correctly.

If necessary, the generator, shaft and bearings etc, should be inspected to determine the cause of the excessive vibration. Rebalancing of the generator rotor may be required.

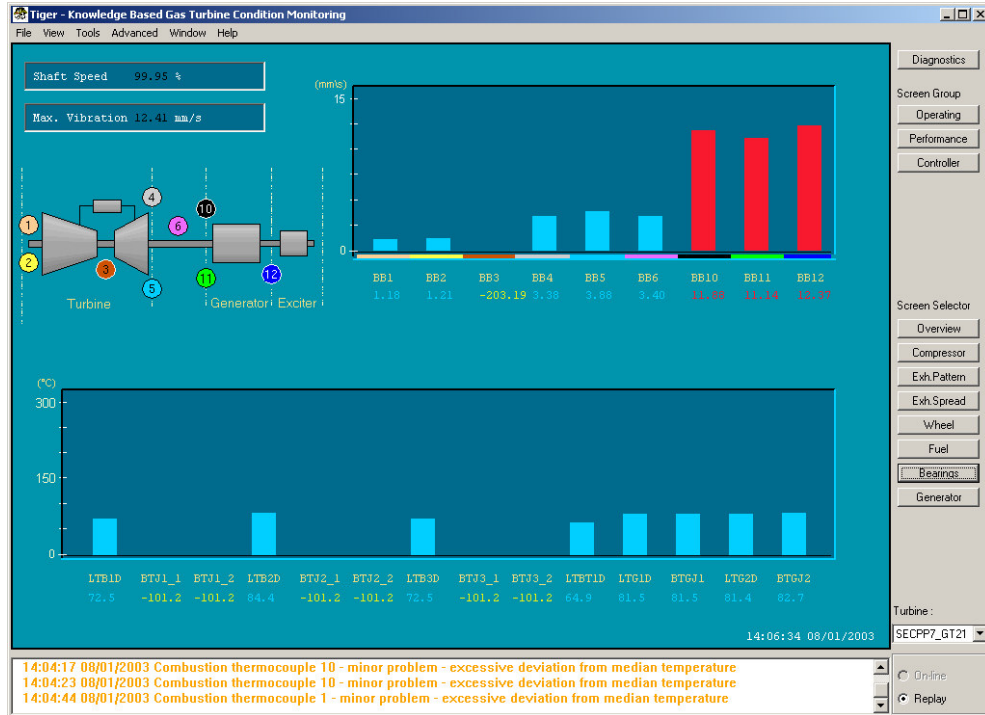
Bearing screen with failed thermocouples indicated.

These bearing metal temperature thermocouples have failed. They should be fixed as soon as possible, as they can give primary indication of bearing or other turbine faults. For example, the thrust bearing temperatures can be indicative of problems with the compressor or turbine. Also, as the lube oil temperatures are high on the generator, it is very important to have the metal temperatures also, as the high lube temperatures may also indicate high metal temperatures. High bearing metal temperatures can be indicative of lube problems, misalignment or bearing wear.

Check the wiring and thermocouples, and repair or replace as necessary.

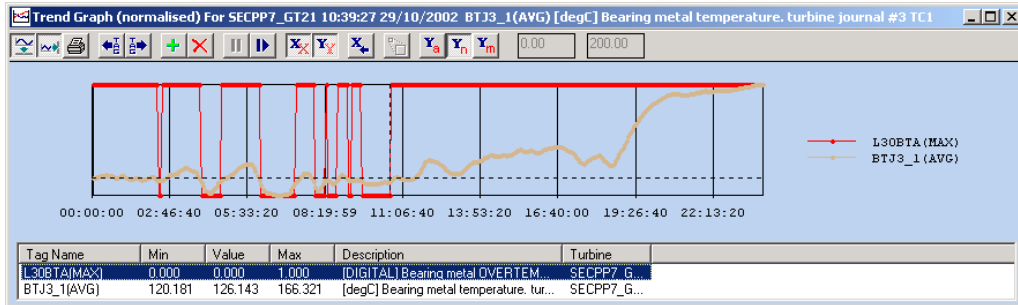
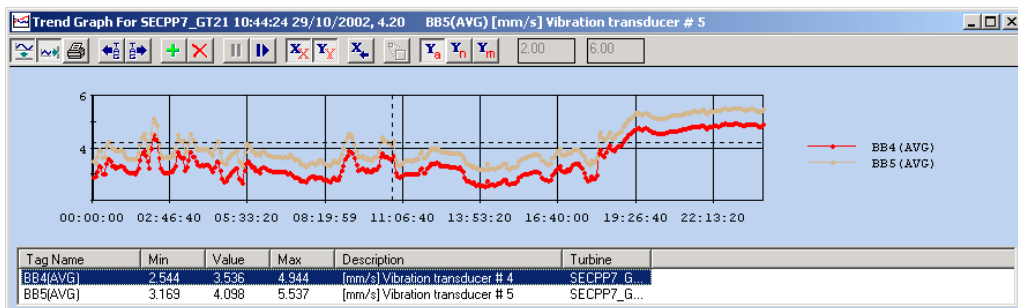
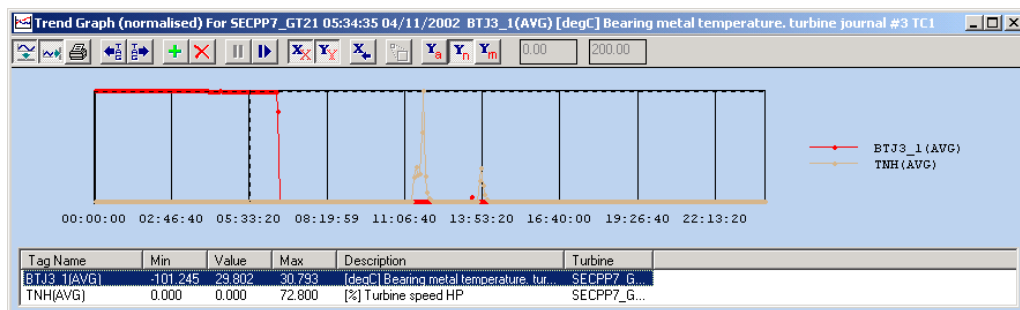
Daily trend graph showing overtemperature alarm and bearing 3 metal temperature.

This thermocouple was reading very high. This could have been due to thermocouple, bearing or lube problems. As the other thermocouple in the pair has failed the reading of thermocouple 1 cannot be checked against the other reading. The lube drain temperatures for bearings 1, 2 & 3 are all very similar in levels and behaviour, so this may also indicate that the bearing metal temperature thermocouple reading is inaccurate. The vibration levels on bearing 3 (BB4 & BB5) are also higher than bearing 1 (BB1 & BB2), but still fairly low. This would also tend to indicate that there are no significant bearing problems occurring. The failure of the thermocouple on the 4th November would also tend to support this view. This also indicates the importance of having all thermocouples working, in order to be sure if temperature problems are real, or simply due to inaccurate thermocouple readings.

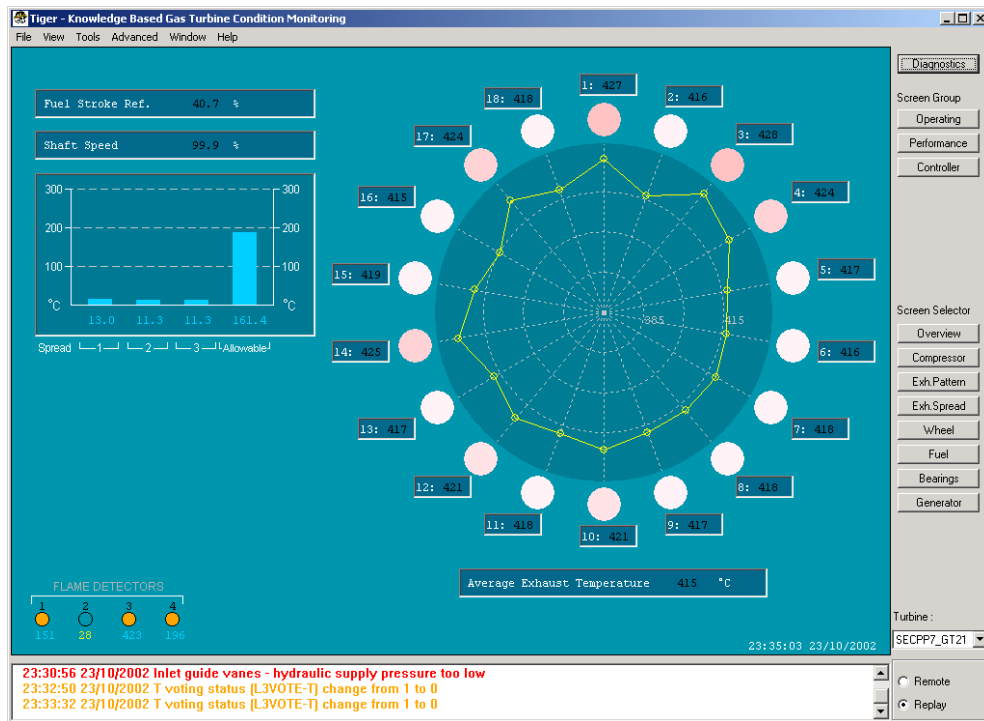
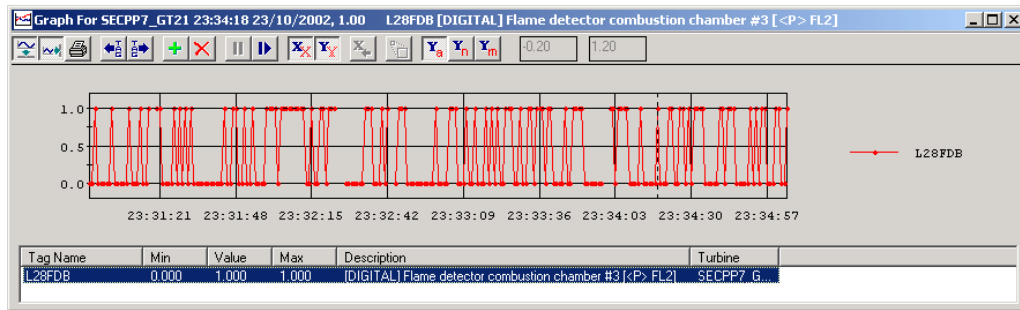
Exhaust pattern screen indicating failed flame detector 2.

Graph of flame detector L28FDB, showing the flickering behaviour.

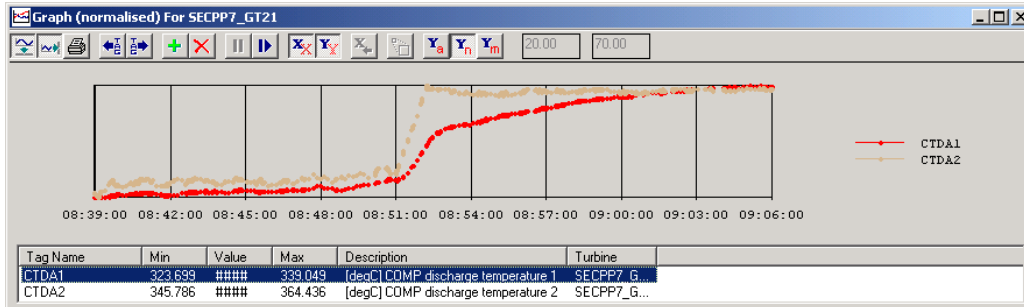
16:35:45 21/10/2002 § Compressor discharge temperature 1 and 2 diverged for 1 seconds by more than 10.00

There is a higher than normal temperature difference between these thermocouples. The two compressor discharge thermocouples differ considerably at one stage by around 30 Deg C, particularly as the GT increases power to base load. The temperature difference is generally less at around 20 Deg C, and has persisted into January 2003. This probably indicates a thermocouple problem.

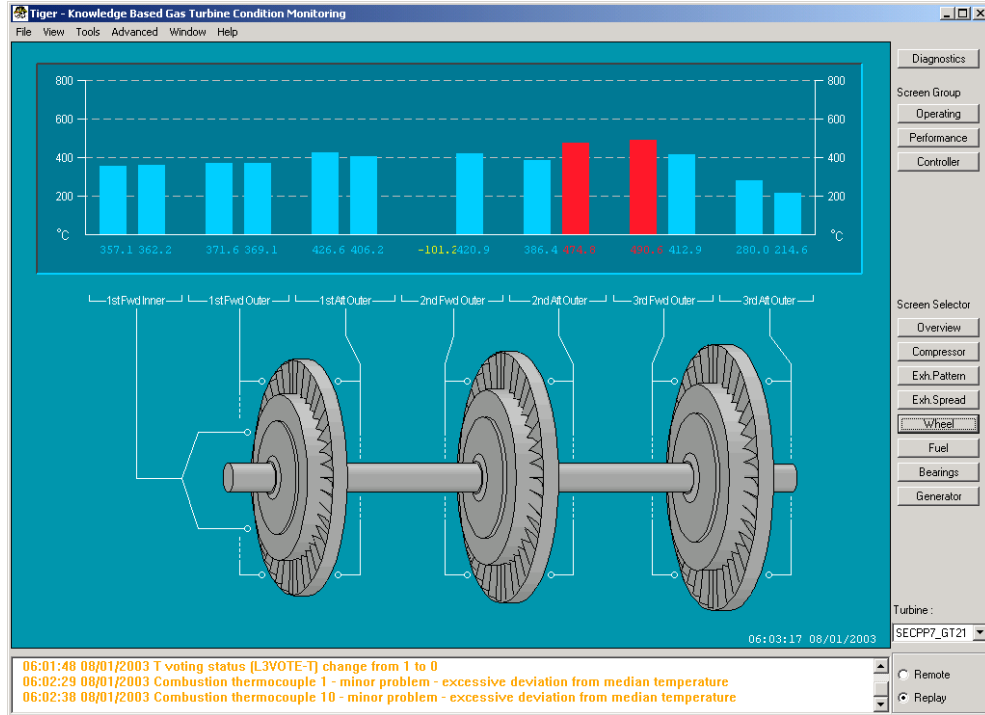
Wheelspace screen a faulty thermocouple.

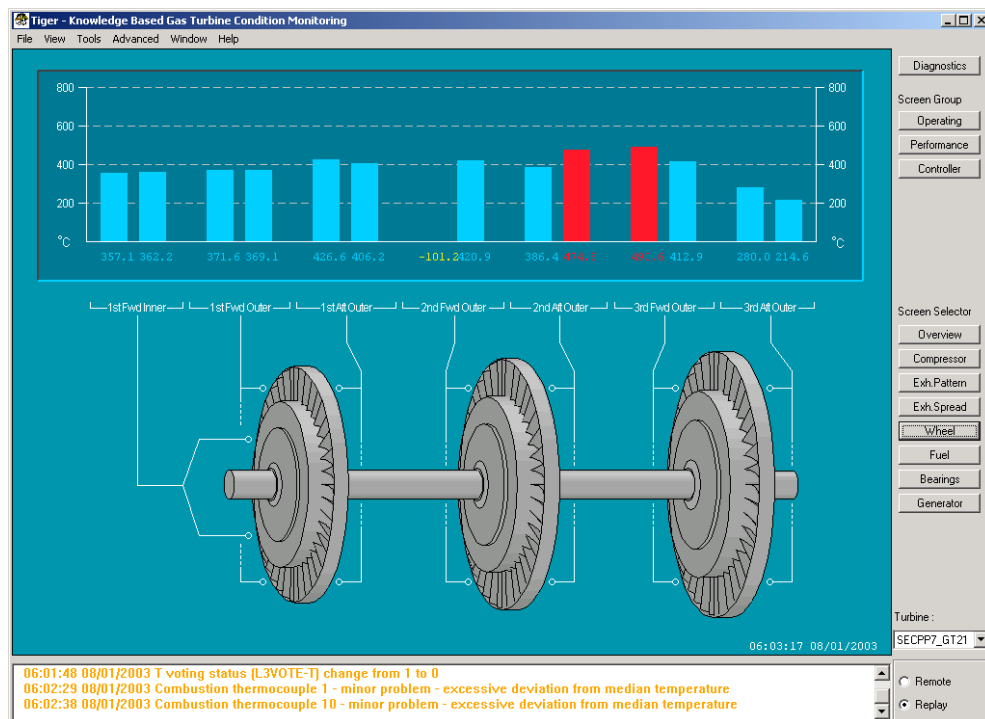
Wheelspace screen indicating high and disparate thermocouple temperatures.

There is a higher than normal temperature difference between some of the thermocouple pairs. This could indicate thermocouple problems, or possible seal leaks. However, these thermocouples rarely detect turbine problems, but can often have sensor problems, such as:

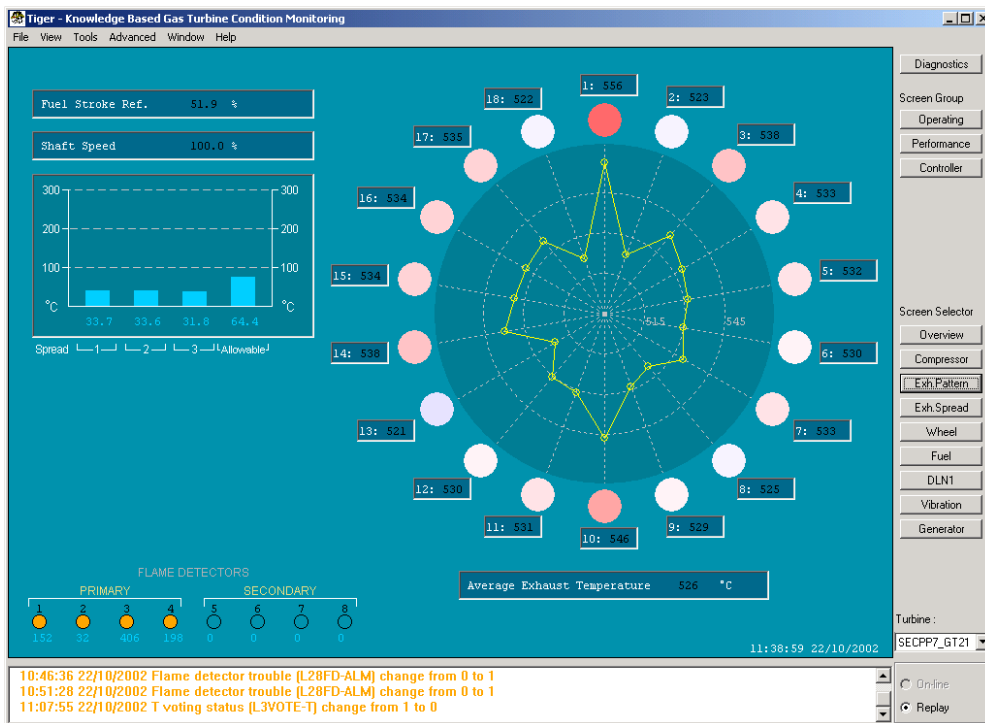
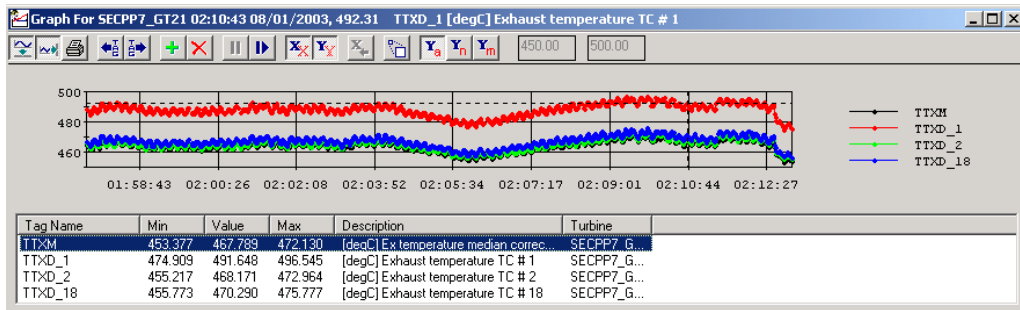
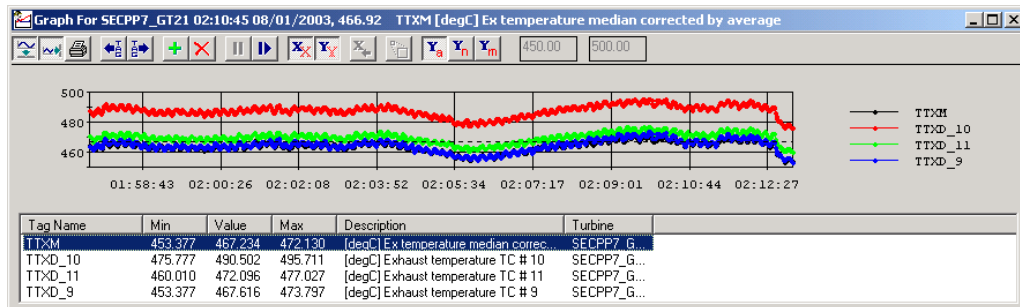
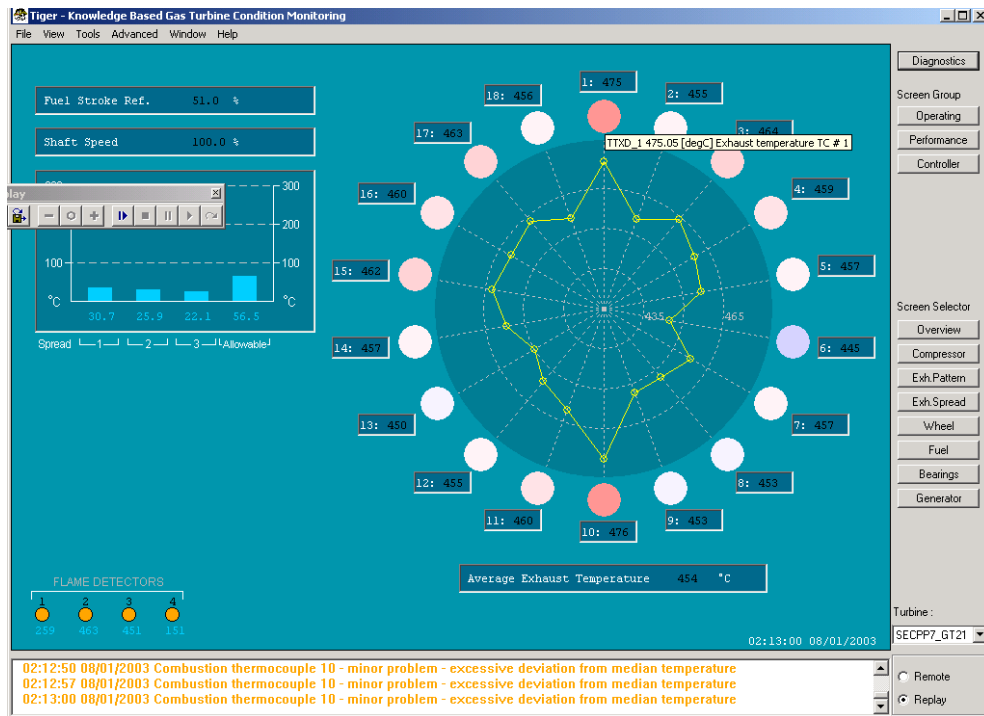
TIGER Exhaust Temperature Pattern Screen – showing problem with thermocouple 1 & 10

The exhaust thermocouple temperature pattern on 8th January 2003 indicates a similar problem with thermocouples 1 and 10 to that in October 2002.

This could indicate a thermocouple or combustion problem. As indicated by the TIGER diagnostics this is most likely to be a thermocouple problem, as the adjacent thermocouples are reading normally. The problem appears to have stayed fairly constant during this time, which may also indicate it as more likely to be a problem with the thermocouples rather than combustion related. The large number of messages generated reflects the fact that the problem is near the bottom end of the range of severity, as TIGER detects the problem as it increases past the diagnostic limits on successive occasions. The problem on thermocouple 10 is listed as minor by TIGER as it is less severe, and the problem with thermocouple 1 is also listed as minor as during some periods when the problem becomes less severe and is then categorised as minor rather than major by TIGER diagnostics. The example data set for the 8th January indicates this.

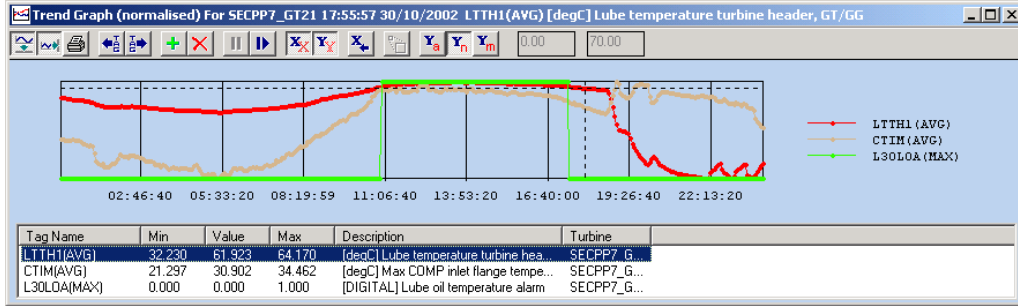
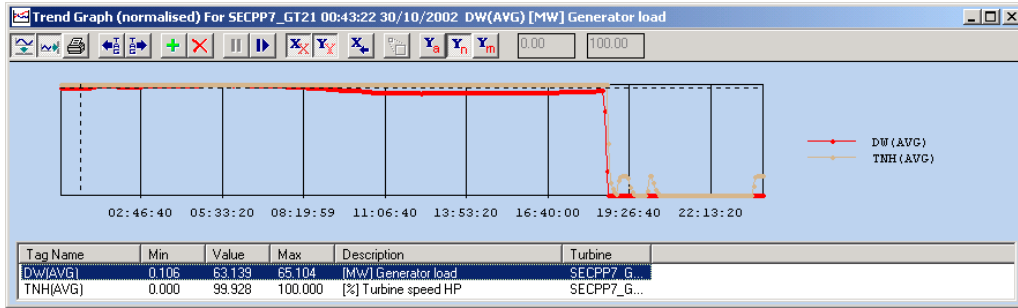
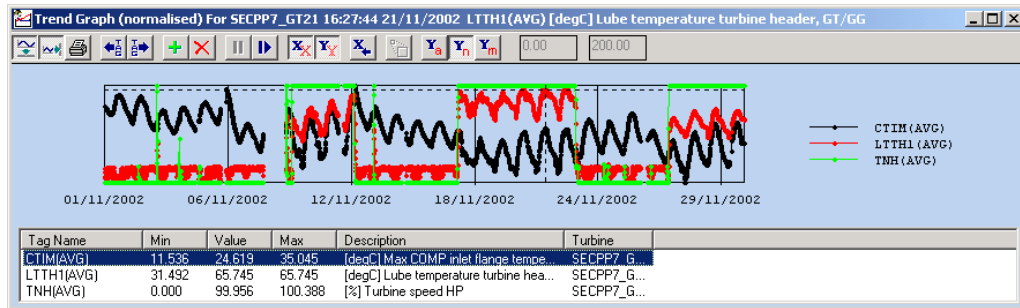
Lube oil header and ambient temperature, lube oil high temperature alarm.

The trend graph for five days in November indicates how lube oil temperatures vary with ambient temperatures, and rise above the alarm limit, causing alarms. The turbine is running throughout this period.

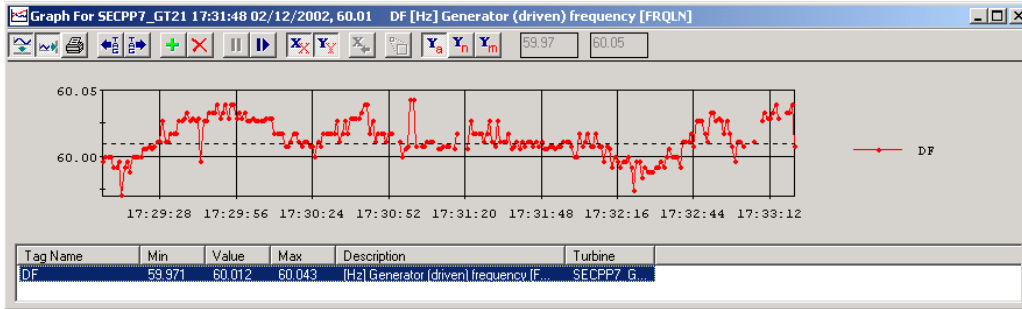
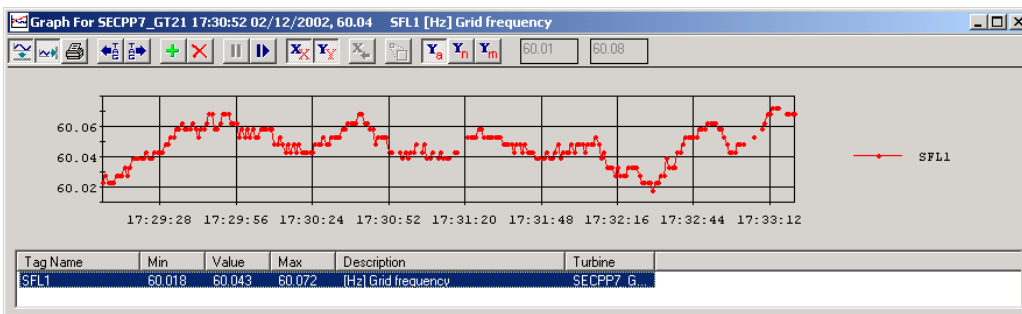
These small spikes in the generator frequency continue to occur periodically. This may be due to instrumentation noise, or possibly to grid frequency instability which may occur faster than the TIGER sample time of 1 second. It could also indicate generator problems. At this stage this is a minor problem, either due to electrical noise or grid instability.

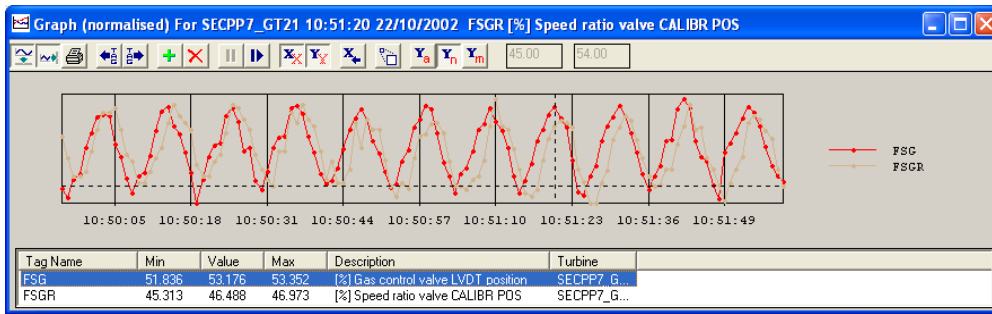
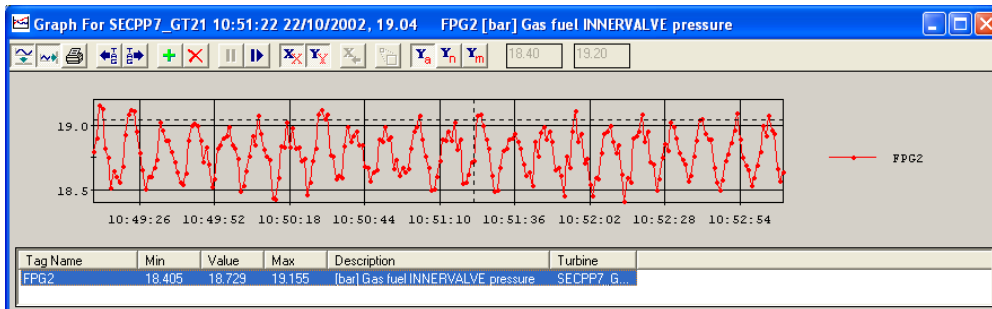
The Speed Ratio Valve (FSGR) is following the FSG Valve as seen in this zoomed image:

This causes oscillations in the P2 Pressure:

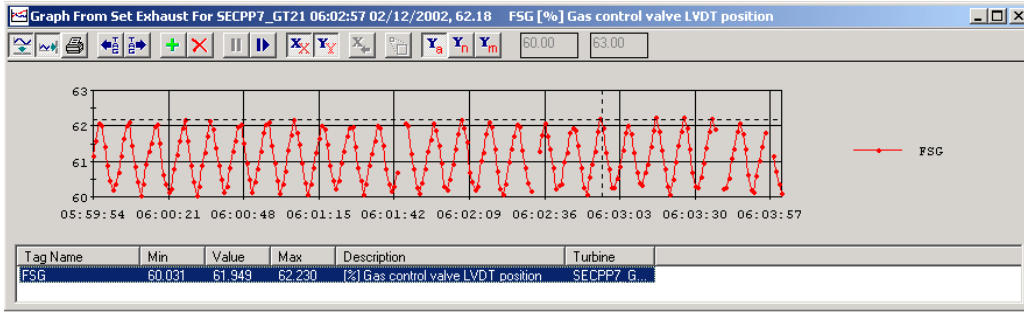
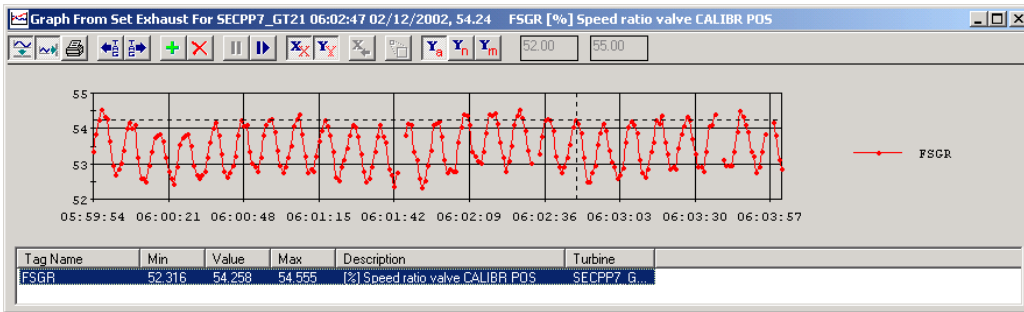
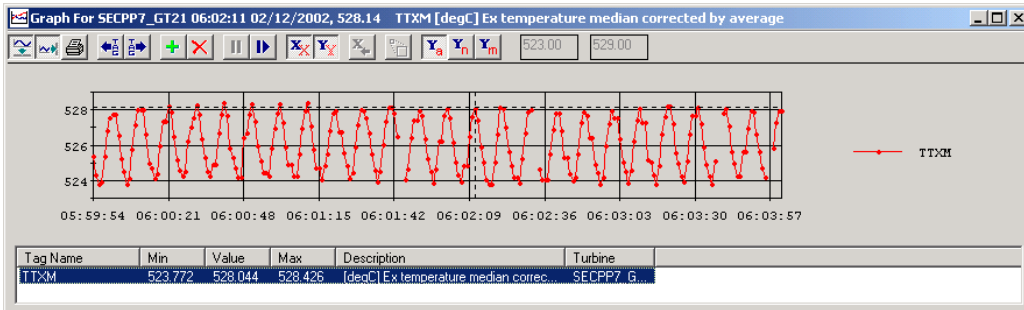
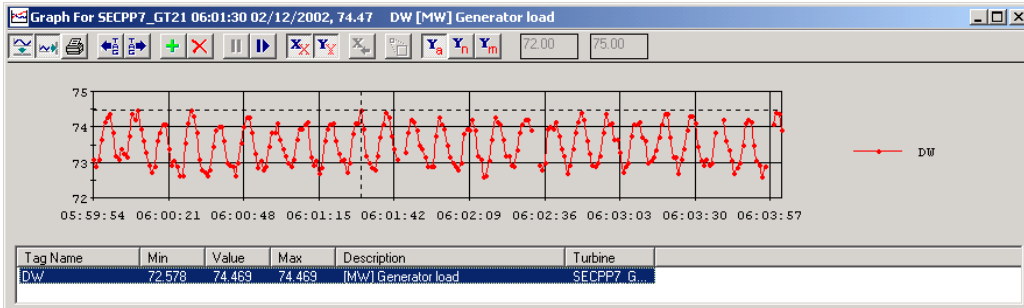
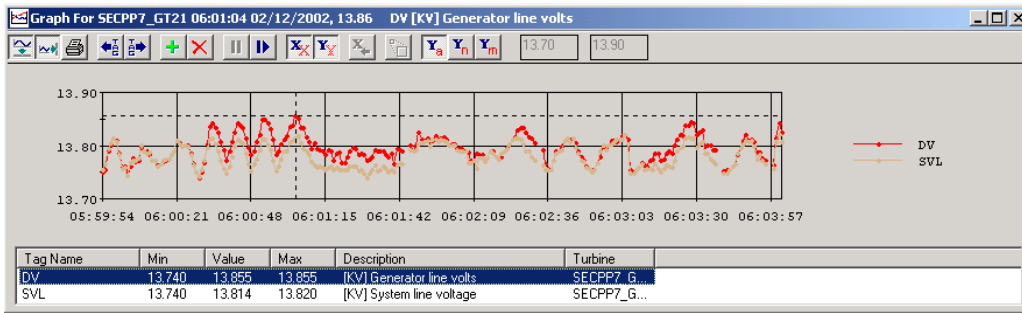
Fuel Control Valve Oscillations

Although these oscillations are relatively small, they are abnormal. The thermal cycling caused by the oscillations will cause increased wear and tear to the hot gas path and other components and reduce component life. These oscillations will also reduce turbine performance.

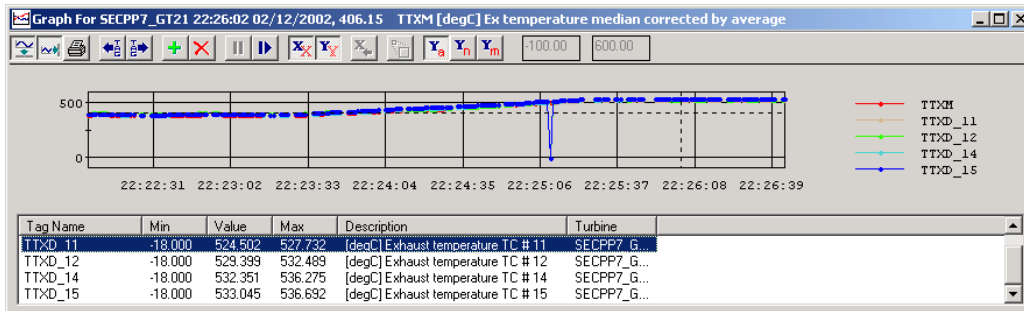
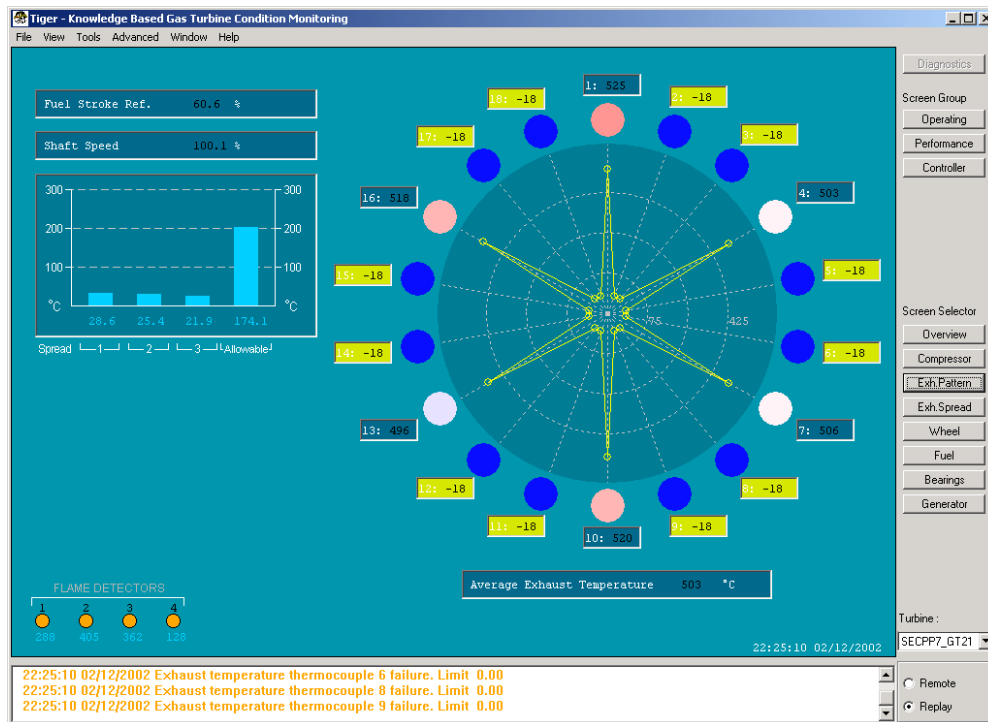
Drop out of exhaust thermocouples due to s&t processor drop-out

Tiger exhaust temperature pattern screen – shows thermocouple drop outs

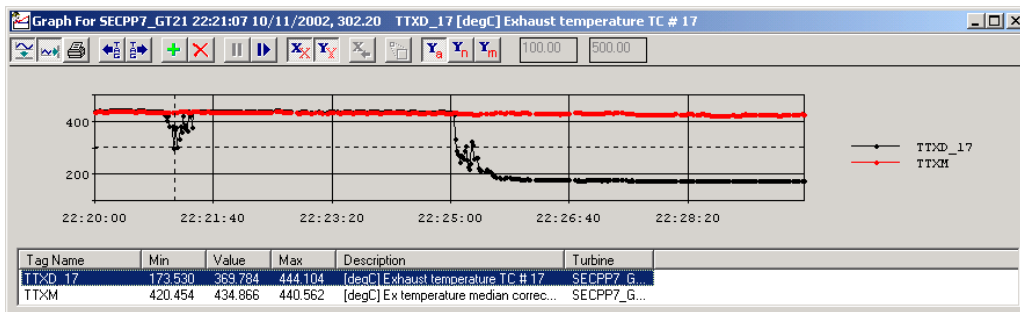
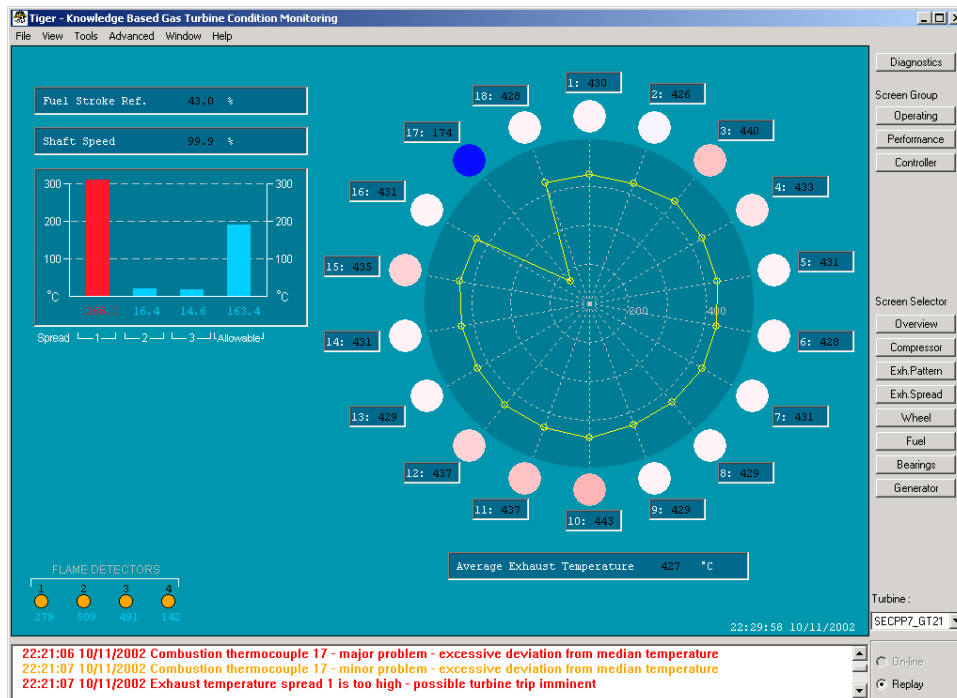
Thermocouple 17 and average exhaust temperature.

Exhaust pattern screen with high exhaust temperature spread 1 and thermocouple 17 failed.

Thermocouple 17 starts failing at around 22:21:06. This causes the high spread value. It finally fails completely about five minutes later at around 22:25:09. This could be caused by a short circuit in the thermocouple, giving a spurious low reading. There could also be a short circuit in the termination box or in the wiring connections to the controller.

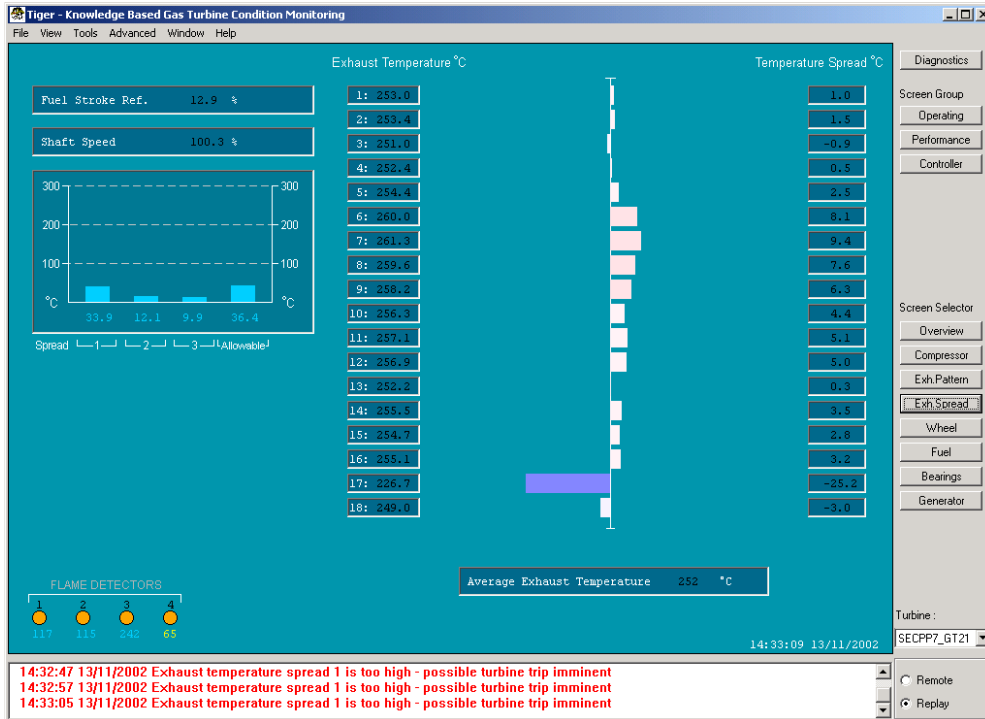
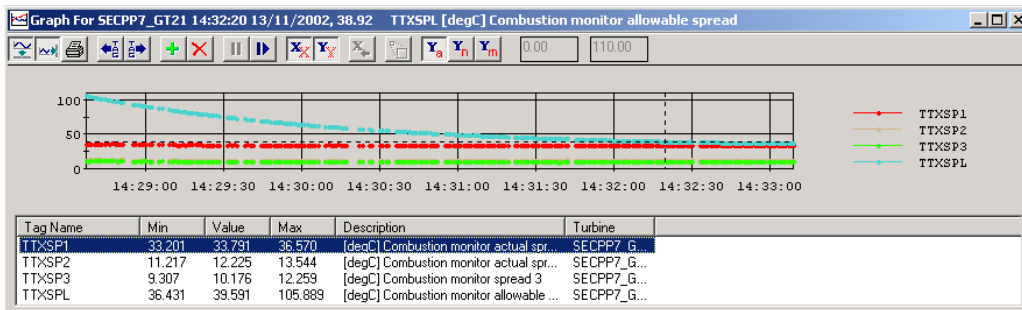
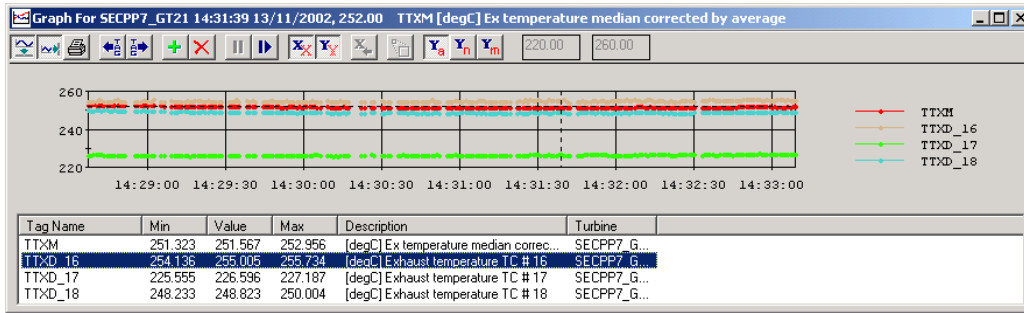
Exhaust Temperature Spread Screen – shows problem with thermocouple 17

There have been spread 1 problems occurring quite frequently, up to this time, most likely due to the low readings on thermocouple 17.

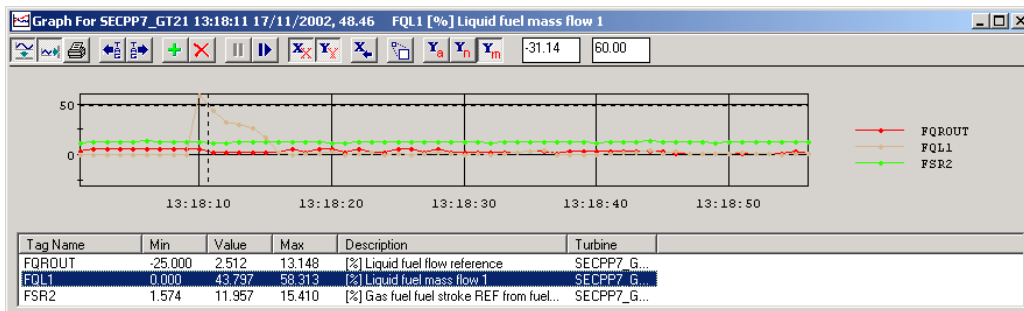
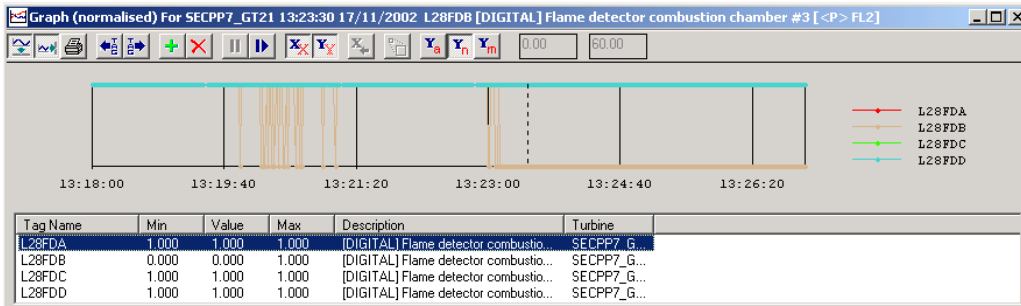
Erratic liquid fuel, prior to transfer

Erratic flame detector 2 during fuel transfers.

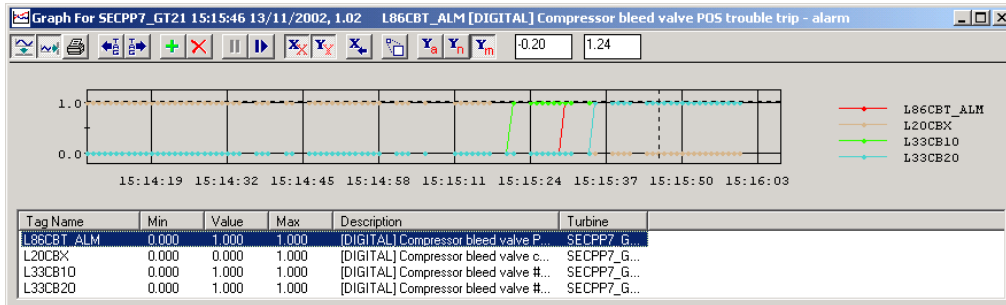
This is a minor problem, and occurs as one of the compressor bleed valves has too long delay in opening after the controller open command. This may indicate that the bleed valve is sticking.

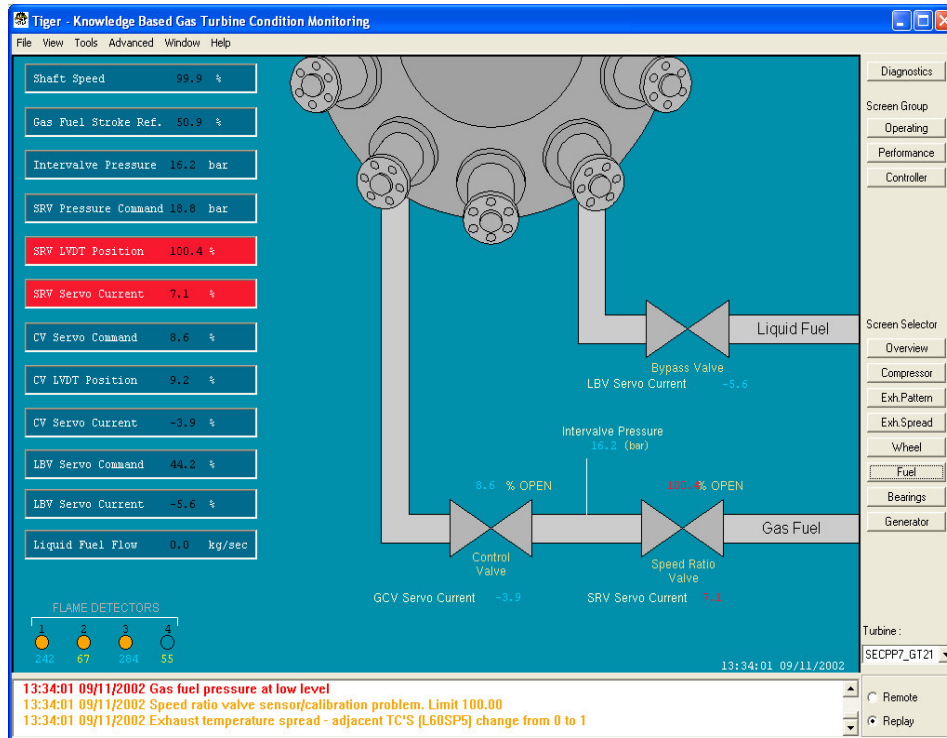
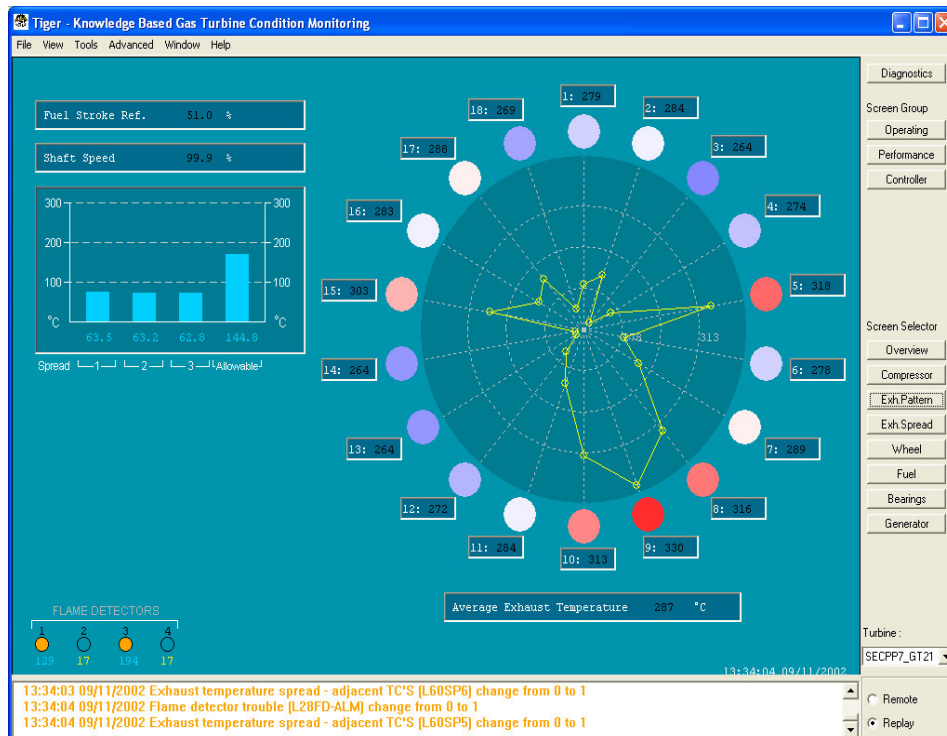
Flame lost on one flame detector

Finally, the gas control valve is nearly closed, and speed ratio valve is fully open. This indicates low gas pressure, and low gas supply to the turbine. There is still no liquid fuel supply. Hence, flame is then lost at flame detector 4, then flame detector 2 one second later, followed by a complete flame out trip.

During the fuel transfer there are problems with low and unstable gas fuel pressure. However, critically there is no liquid fuel supply, so the turbine eventually trips on flame out as the gas fuel is reduced but no liquid fuel is supplied to replace it. This was an operational problem, as it appears the manual stop valve for the liquid fuel was off when a fuel transfer was attempted. Hence it failed.

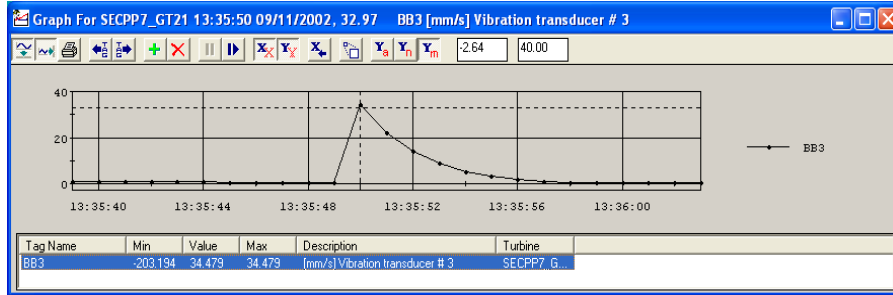
BB3 Vibration during run down

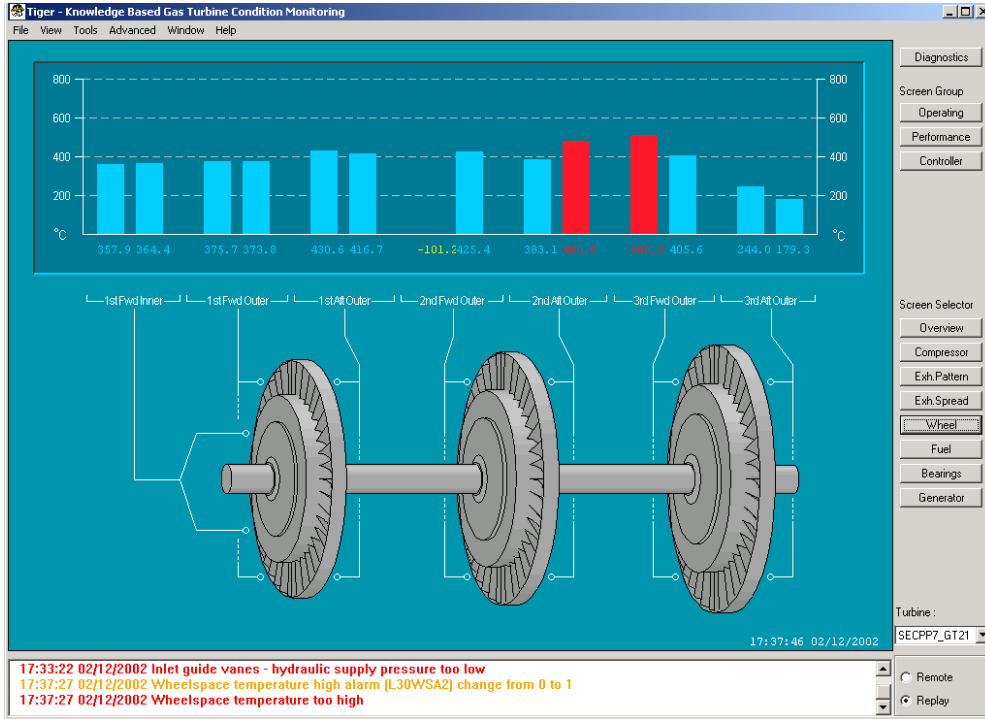
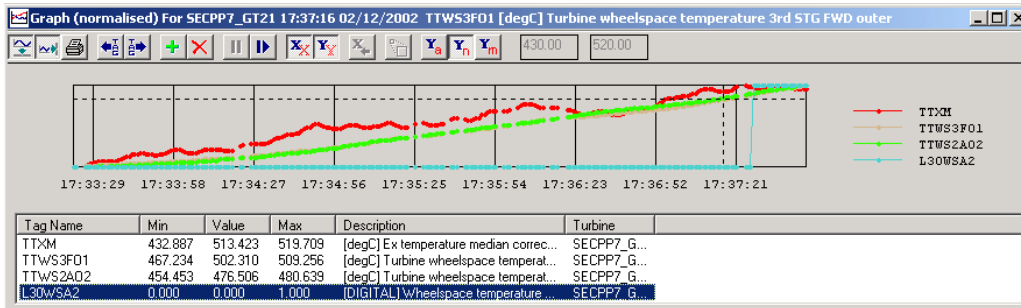
TIGER Wheelspace Screen – example of high temperatures

Wheelspace and exhaust temperatures increasing and triggering alarm

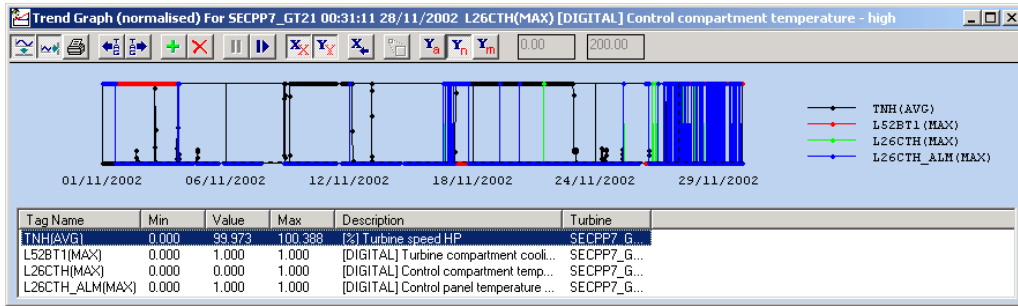
Turbine compartment cooling fan, controller compartment high temperature alarms and speed.

The monthly trend graph for October indicates how the controller compartment temperature alarms are triggered for extended periods. Speed is included to indicate when the turbine is running or stopped.

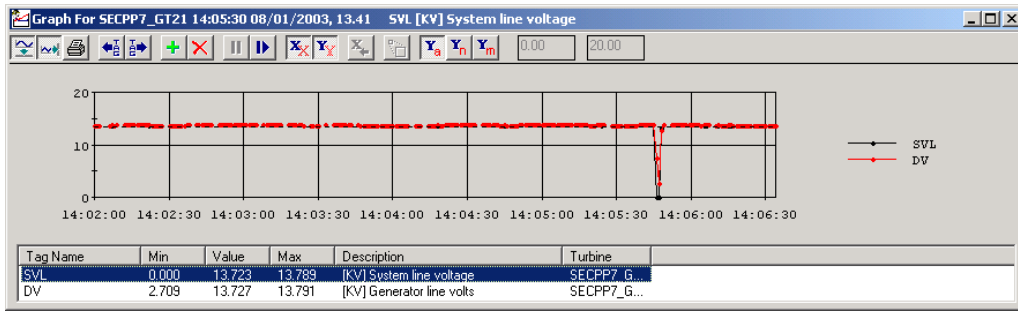
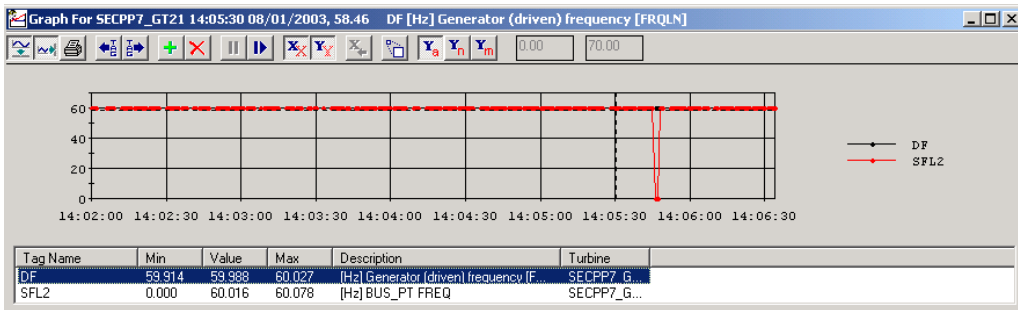
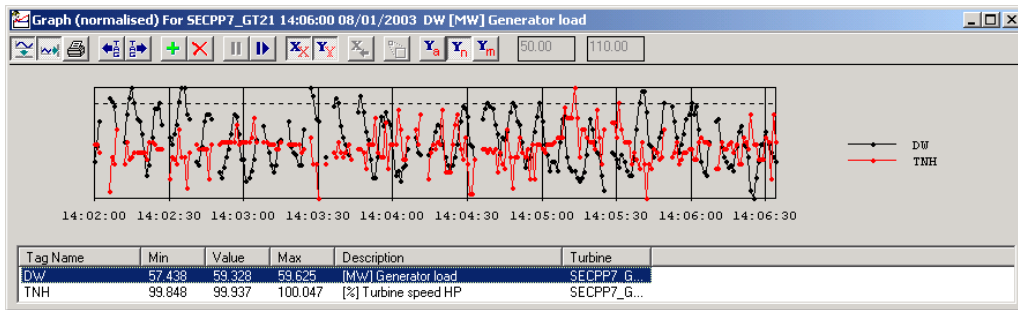
Selecting a particular dropout at around 14:00, we can see that it is detected by the various TIGER diagnostics. However, as can be seen from the graphs below, there is no effect on speed or power. TIGER diagnostics also detect a discrepancy between generator and grid voltage and generator and grid frequency.

On a normalised scale, both turbine speed and power just show noise with no transients related to the grid electrical disturbances indicated by the various electrical sensor data graphed above.
