TIGER® Diagnostic Report

***Diagnostic Analysis Report
for
GE Frame 7 Gas Turbine
at
Power Plant***

EXECUTIVE SUMMARY

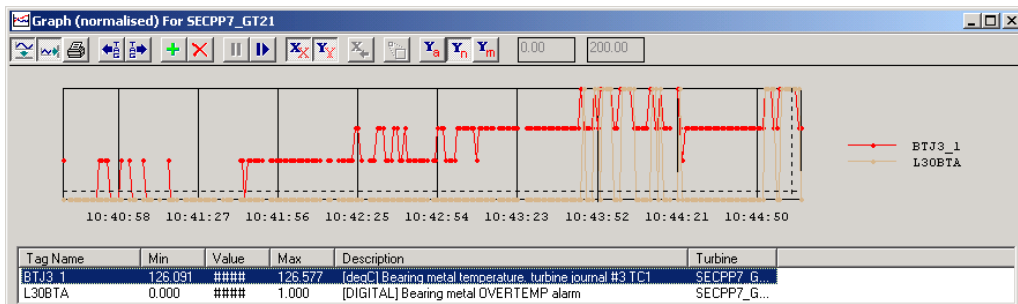
4.	BEARING METAL TEMPERATURE – OVER TEMPERATURE ALARMS	<p>This thermocouple was reading very high. This could have been due to thermocouple, bearing or lube problems. As the other thermocouple in the pair has failed the reading of thermocouple 1 cannot be checked against the other reading. The lube drain temperatures for bearings 1, 2 & 3 are all very similar in levels and behaviour, so this may also indicate that the bearing metal temperature thermocouple reading is inaccurate. The vibration levels on bearing 3 (BB4 & BB5) are also higher than bearing 1 (BB1 & BB2), but still fairly low. This would also tend to indicate that there are no significant bearing problems occurring. The failure of the thermocouple on the 4th November would also tend to support this view. This also indicates the importance of having all thermocouples working, in order to be sure if temperature problems are real, or simply due to inaccurate thermocouple readings.</p> <p>The most likely cause is therefore a faulty thermocouple. This could be due to a short circuit in the thermocouple tube (which is a metal filled tube filled with mineral insulation), or the thermocouple tube is contacting other hot metal parts. It is probably detecting a hot air temperature inside the turbine, and not the actual metal temperature.</p>	Check thermocouples 1 and 2 and wiring, and repair as required. If thermocouples 1 and 2 still indicate high temperatures. If they do, check the no 3 bearing and the associated lube system.

10:43:27 29/10/2002 Bearing metal temperature. turbine journal #3 TC1 [BTJ3-1] too high. Limit 100.00 degC

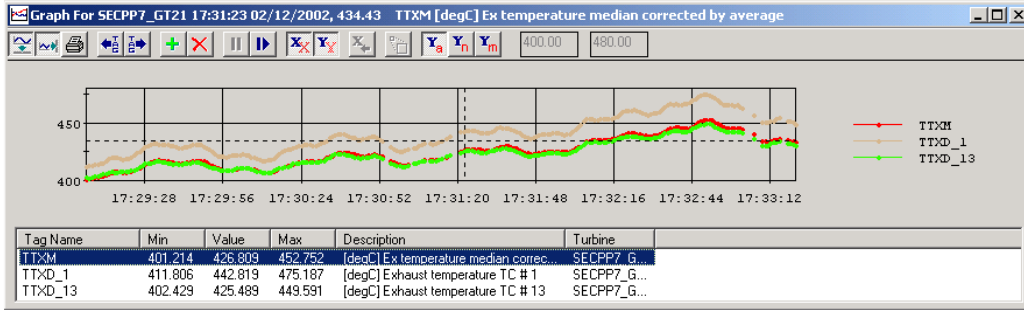
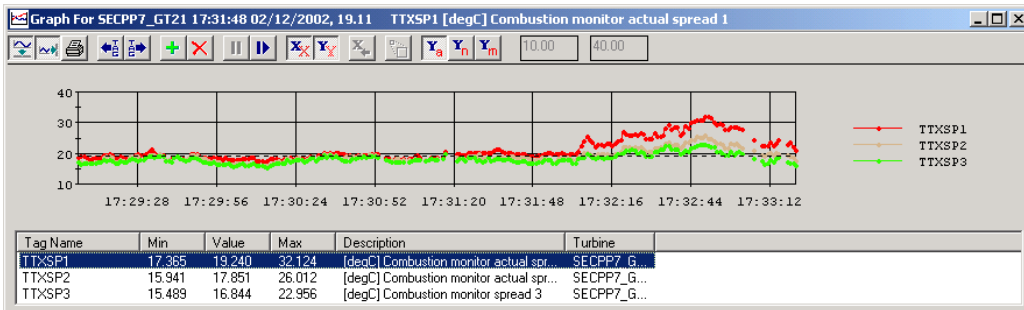
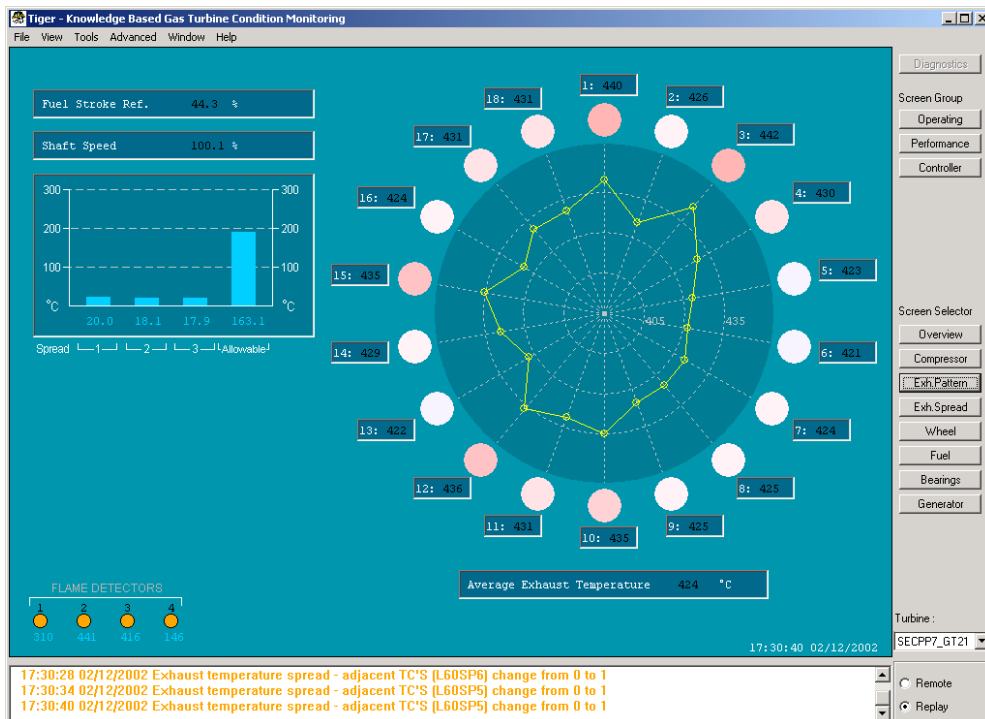
TIGER detects frequent occurrences of alarms L60SP5 (Exhaust temperature spread - adjacent TC'S) & L60SP6 (Exhaust temperature spread - adjacent TC'S). However, it is not clear what is generating these. They occur even though the exhaust temperature spread is low. An example of this occurs at 17:30 on 02/12/2002.

In this example data set, the turbine is running at part load, and there is some instability in the exhaust temperatures, presumably due to gas supply pressure fluctuations. No major transients occur in the exhaust temperature spreads during this time. Also, although the spreads do increase somewhat towards the later part of the data sequence as turbine power is increased, the spreads are quite low throughout.

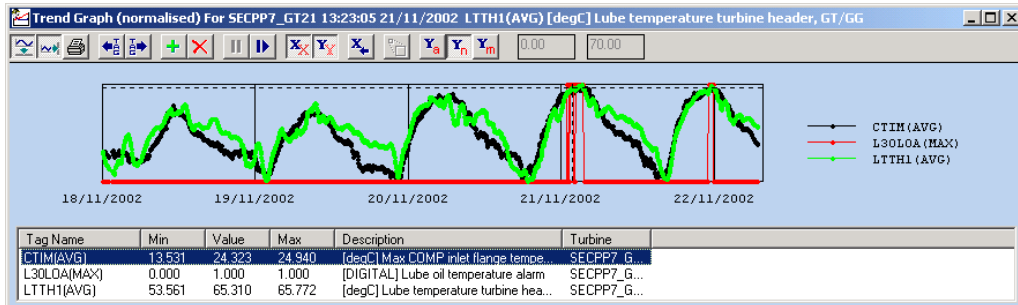
Lube oil header and ambient temperature, lube oil high temperature alarm.

12.	LUBE OIL TEMPERATURE PROBLEMS	<p>The problem with the lube oil header temperature was first indicated by TIGER warning messages on the 21st October, and this problem also causes controller alarms to occur, as the temperature rises. On the 30th October, first TIGER generates warning messages as the temperature rises above the TIGER limit of 58 Deg C with the ambient temperature increase, and then controller alarms occur. The controller alarm clears when the turbine is shutdown. These high temperatures could also be related to the high vibration levels on the generator. There is also the possibility that this thermocouple is not reading accurately.</p> <p>The controller alarm (L30LOA) has not occurred since 22nd November 2002. Examination of the monthly trend graph for November indicates that this is probably to the falling ambient temperatures during the month.</p> <p>This is a significant problem. Lube oil temps should be in the range 54 – 70 Deg C (lube oil header temperature), but they are higher than this and vary with ambient temperatures rather than staying constant. If turbine is too hot, this can cause problems with the bearings including problems with misalignment, particularly at the generator end of the turbine, where the support legs can get too hot and distort.</p> <p>The high lube temperatures may be caused by cooling system problems. This could be caused by clogging of radiators (e.g. sand) or cooling fan problems. There is also a low water cooling level alarm present. It could also be caused by water leakage at the three way water control valve. Alternatively a manual lock may have been applied to the valve so it is not controlling water flow as ambient temperatures change. Or, temperature control of the cooling system is not working for some other reason.</p>	<p>Check the lube oil system and lube oil water cooling system, as a further increase in lube temperatures could lead to a trip, and possibly extra wear on the turbine. Check the water cooling system for:</p> <ul style="list-style-type: none"> ➤ clogging of radiators (i.e. sand) ➤ cooling fan problems ➤ cooling water reservoir level ➤ water leakage at the three way water control valve ➤ possible manual lock on the control valve ➤ malfunction of the temperature control of the cooling water system

The trend graph for five days in November indicates how lube oil temperatures vary with ambient temperatures, and rise above the alarm limit, causing alarms. The turbine is running throughout this period.

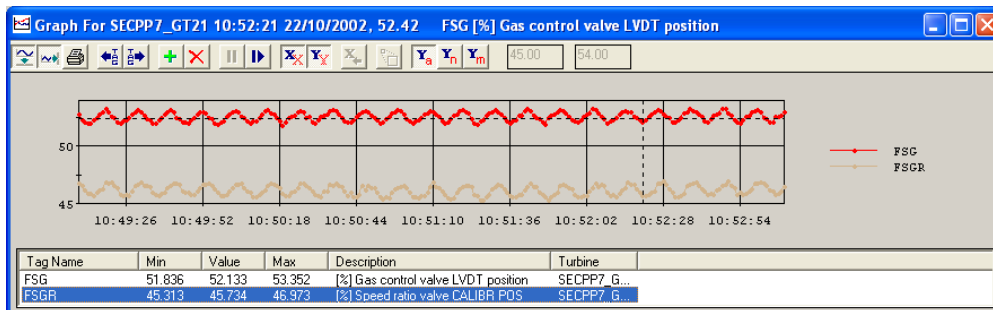
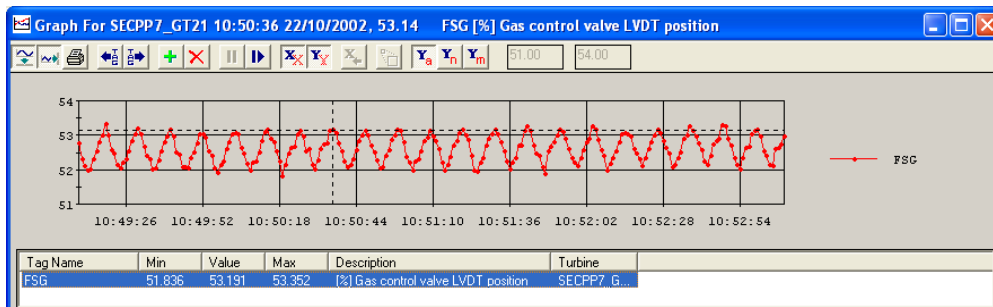
15.	TURBINE OSCILLATIONS	<p>Although these oscillations are relatively small, they are abnormal. The thermal cycling caused by the oscillations will cause increased wear and tear to the hot gas path and other components and reduce component life. These oscillations will also reduce turbine performance.</p> <p>It was possible that these turbine oscillations may be caused by grid voltage oscillations. However, since this happens at FSNL it is more likely to be caused by another internal problem, such as fuel control or gas fuel pressure problems.</p> <p>These oscillations are a significant problem, and are most likely due to fuel control problems. This could be due to controller tuning, hydraulics problems or gas fuel valve component wear. Worn valves are often the cause of this, and even if they are still within the manufacturers tolerance limits, worn valves can cause this type of poor fuel control to occur.</p>	<p>When convenient, try auto tuning the controller and fuel valve system. If this fails, a manual controller and fuel valve tuning could be tried. If this fails, then check the operation of the gas fuel system and the pressure stability of the gas fuel supply. Overhaul and/or replace any worn or faulty fuel valve components as required.</p>

The Following graph shows the two gas fuel valves oscillating continuously:

A close up of the Gas Control Valve (FSG) shows the period to be about once every 10 seconds:

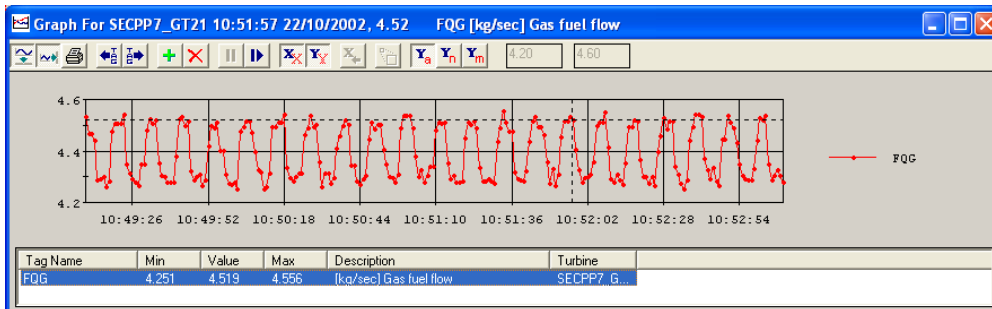
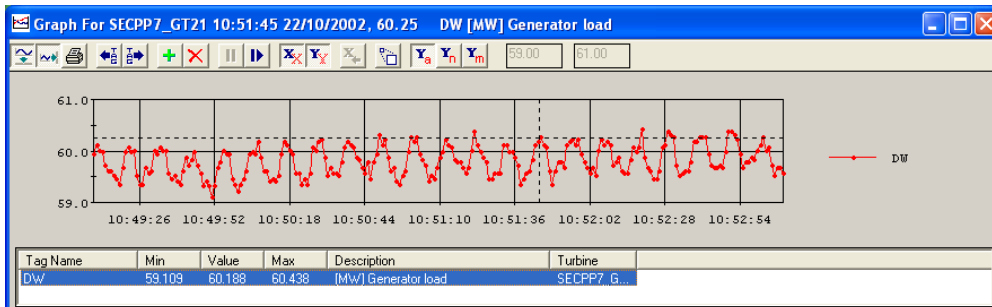
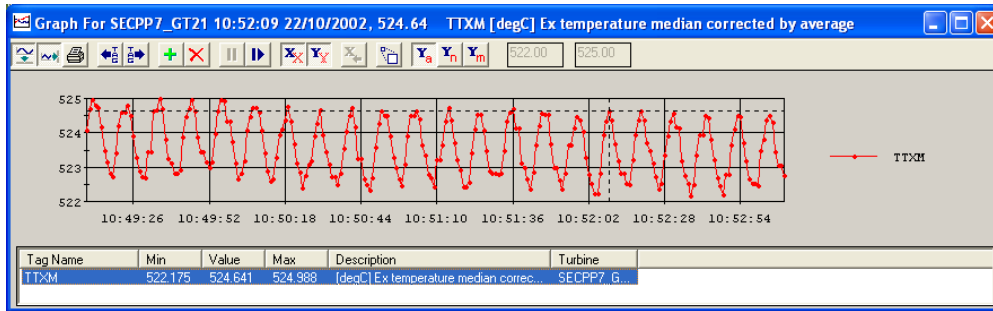
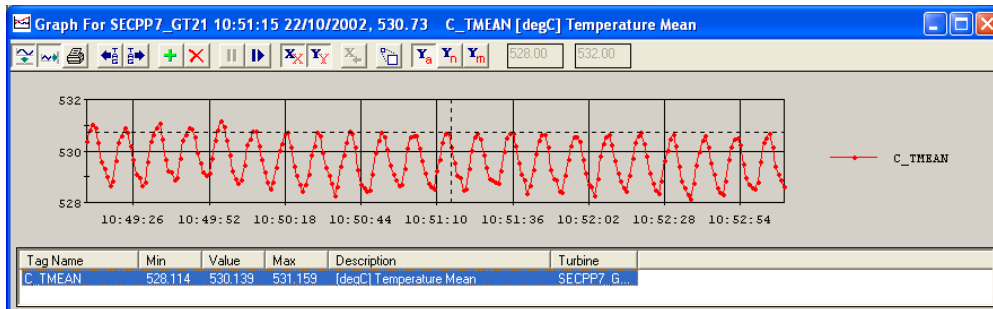
Most importantly, this leads to a constant oscillation of the power output in Megawatts:

The graph of the medium exhaust gas temperature shows the oscillation in temperature.

TIGER's calculated mean exhaust temperature also shows this well:

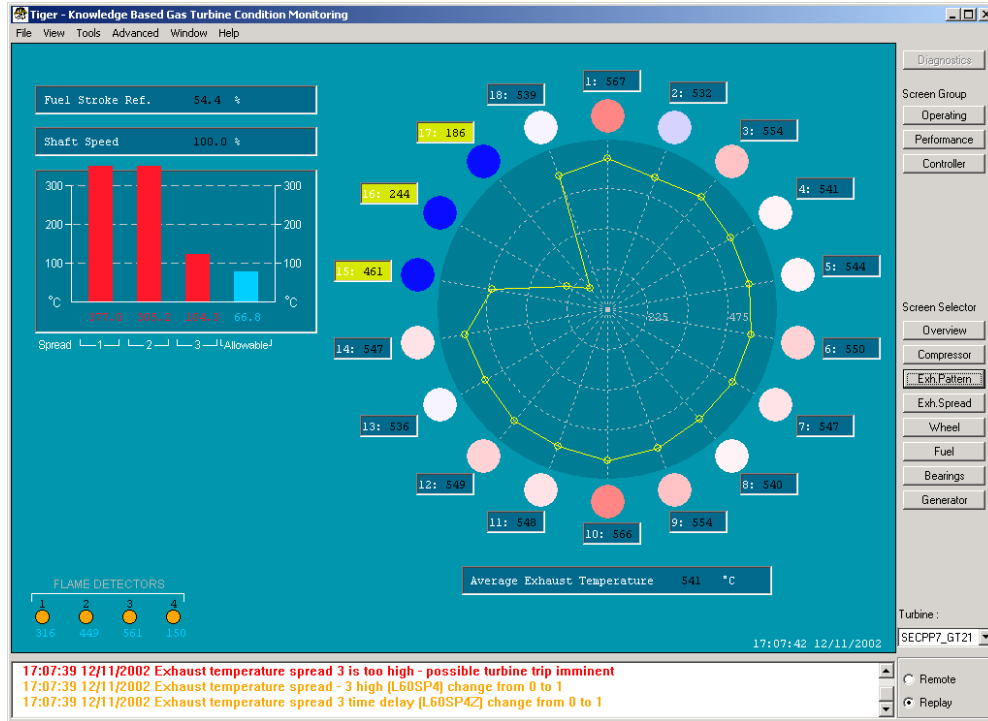
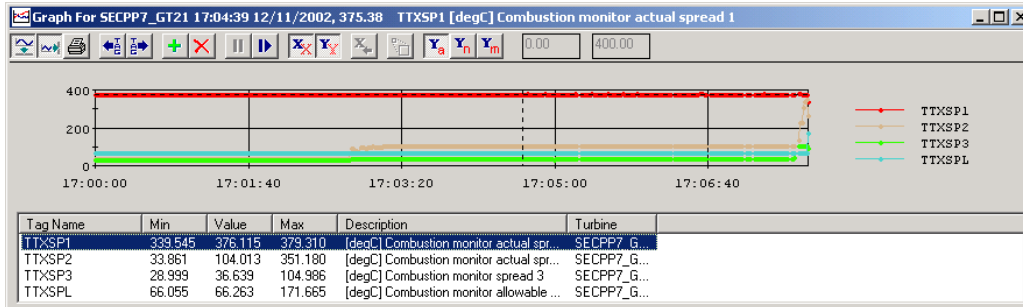
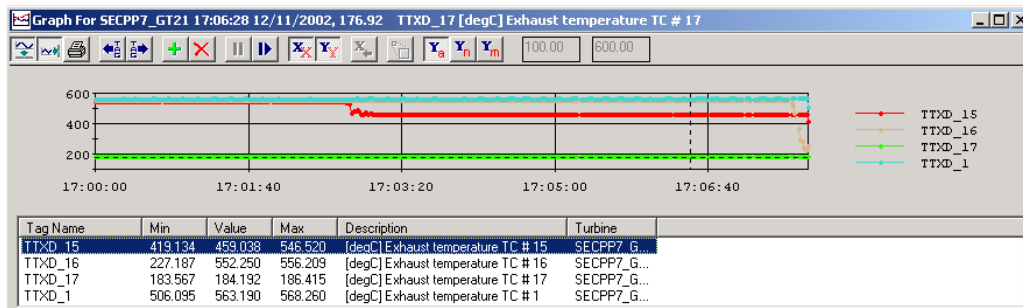
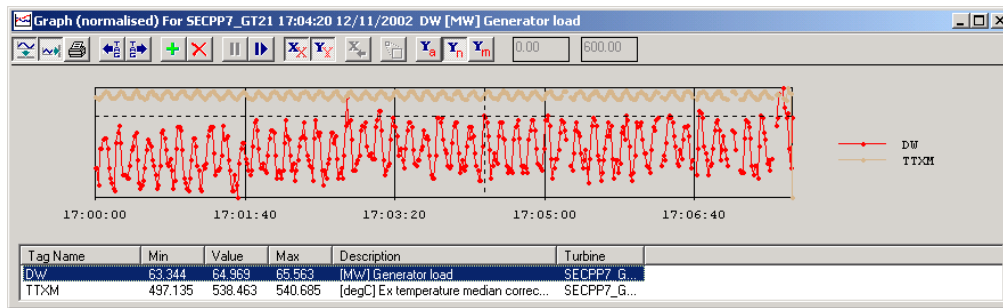
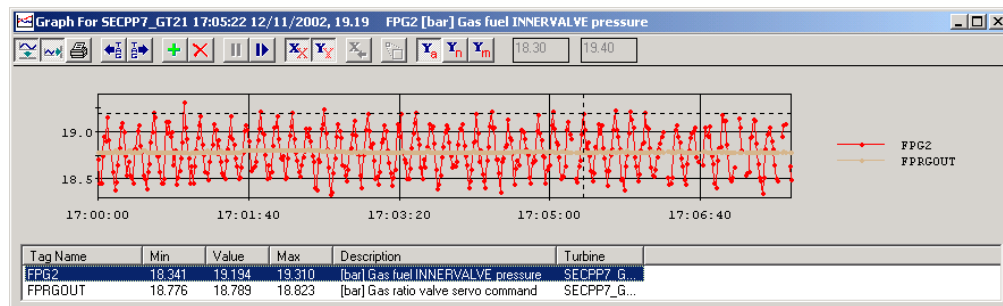
19.	EXHAUST TEMPERATURE SPREAD TRIP	Initially exhaust thermocouple 17 is reading low and there is a high spread. Eventually, 15 and 16 also become low, and this causes the trip. As there is no change in power levels, this is probably due to a thermocouple problem. However, three thermocouples reading low simultaneously is normally indicative of combustion problems. During this time, there is significant instability in the gas fuel control valves, with all major parameters such as power, exhaust temperature and P2 pressure oscillating. It is possible that these problems could also be linked to the cause of the trip, although it is more likely that the problem is related to the incidents on the 10 th and 13 th of November where thermocouple 17 was reading cold and also failed (on the 10 th). This could be caused by a short circuit in the thermocouples, giving a spurious low reading. There could also be a short circuits in the termination box or in the wiring connections to the controller.	Check the wiring and thermocouple. Check for a short circuit in the thermocouple or in the termination box or in the wiring connections to the controller. Repair or replace as necessary. The termination is the most likely location.

The gas turbine is running in a stable state at about 65 Mw, and then trips on exhaust over temperature.

17:00:00 12/11/2002 § Combustion thermocouple 17 - major problem - excessive deviation from median temperature
 17:00:00 12/11/2002 § Exhaust temperature spread 1 is too high - possible turbine trip imminent

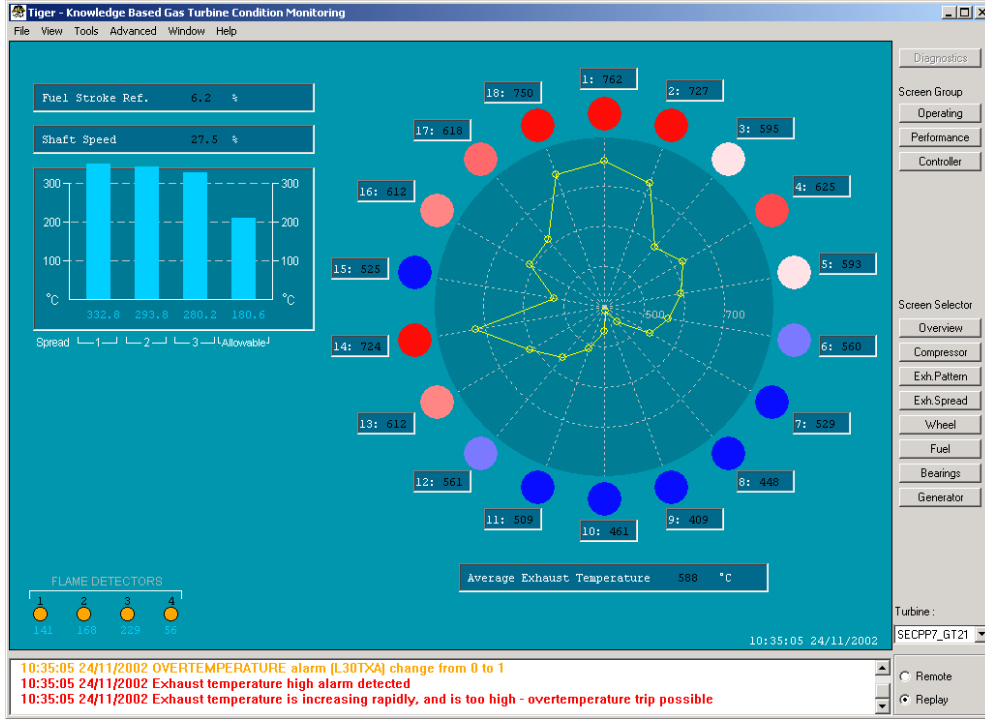
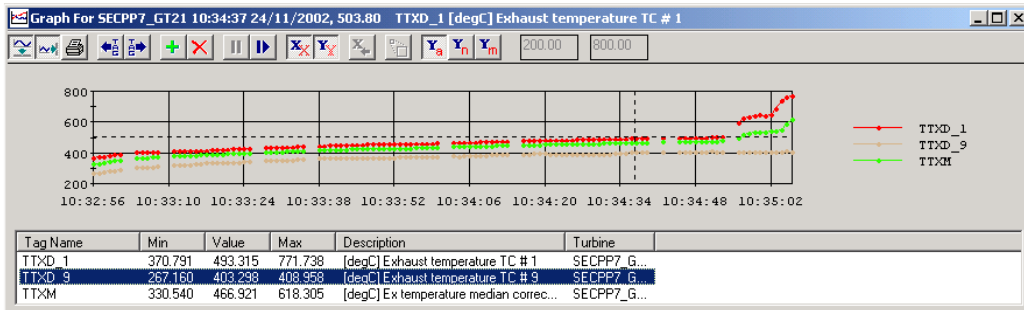
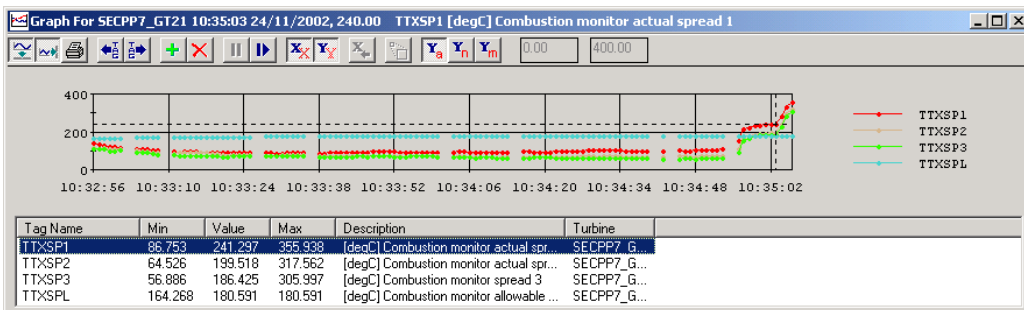
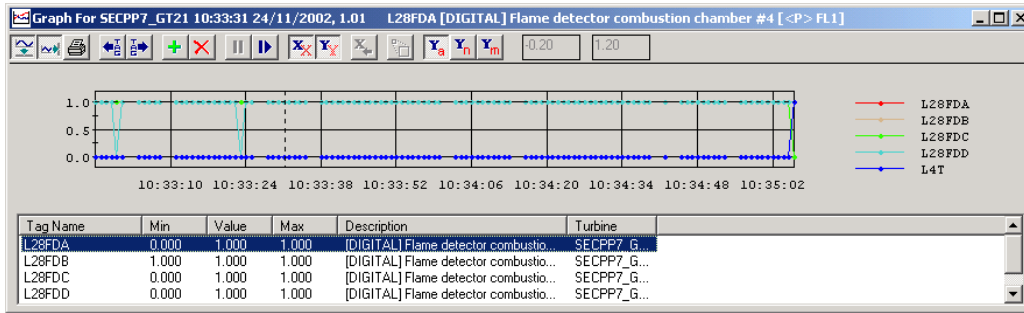
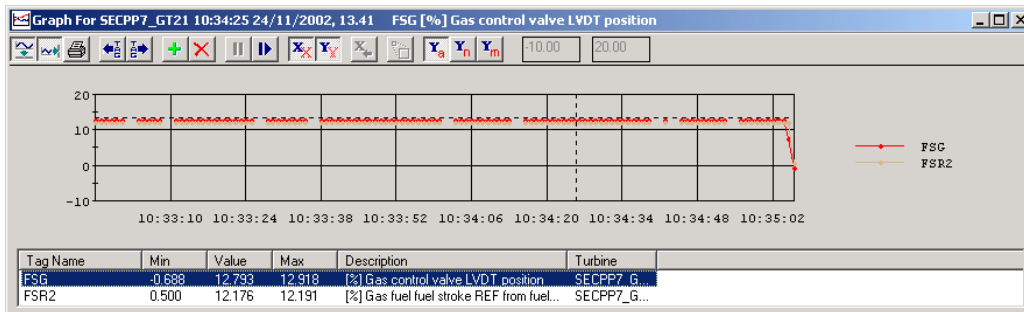
20.	EXHAUST SPREAD PROBLEMS ON STARTUP	This could have been due to a bad thermocouple or combustion problem. This incident was probably related to the previous one on the 10 th November where thermocouple 17 failed, so as indicated by TIGER diagnostics it appeared to be due to a thermocouple problem. This could be caused by a short circuit in the thermocouple, giving a spurious low reading. There could also be a short circuit in the termination box or in the wiring connections to the controller.	Check the wiring and thermocouple. Check for a short circuit in the thermocouple or in the termination box or in the wiring connections to the controller. Repair or replace as necessary.

The turbine trips on exhaust over temperature while starting up on gas fuel.

10:34:58 24/11/2002 § Exhaust thermocouple 17 and 18 diverged for 1 seconds by more than 90.00
 10:34:59 24/11/2002 § Exhaust thermocouple 14 and 15 diverged for 1 seconds by more than 90.00
 10:35:04 24/11/2002 § Exhaust thermocouple 2 and 3 diverged for 1 seconds by more than 90.00
 10:35:05 24/11/2002 § Exhaust thermocouple 13 and 14 diverged for 1 seconds by more than 90.00
 10:35:05 24/11/2002 » Exhaust temperature is increasing rapidly, and is too high - overtemperature trip possible
 10:35:06 24/11/2002 » Controller trip signal to protective module
 10:35:06 24/11/2002 » Post ignition trip
 10:35:06 24/11/2002 » Turbine trip due to exhaust over temperature

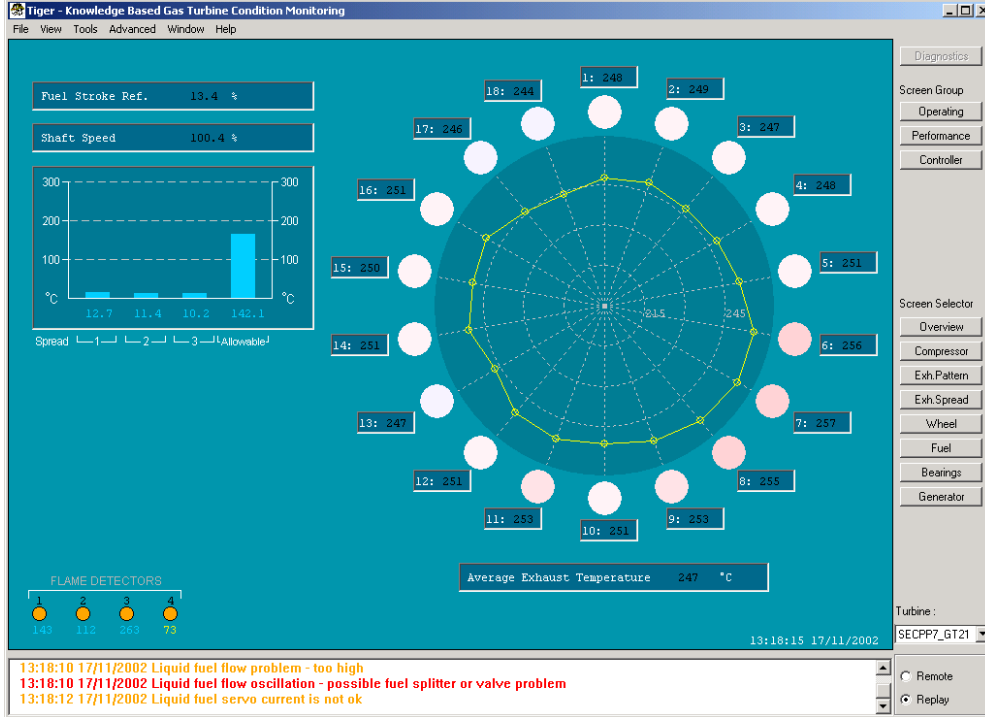
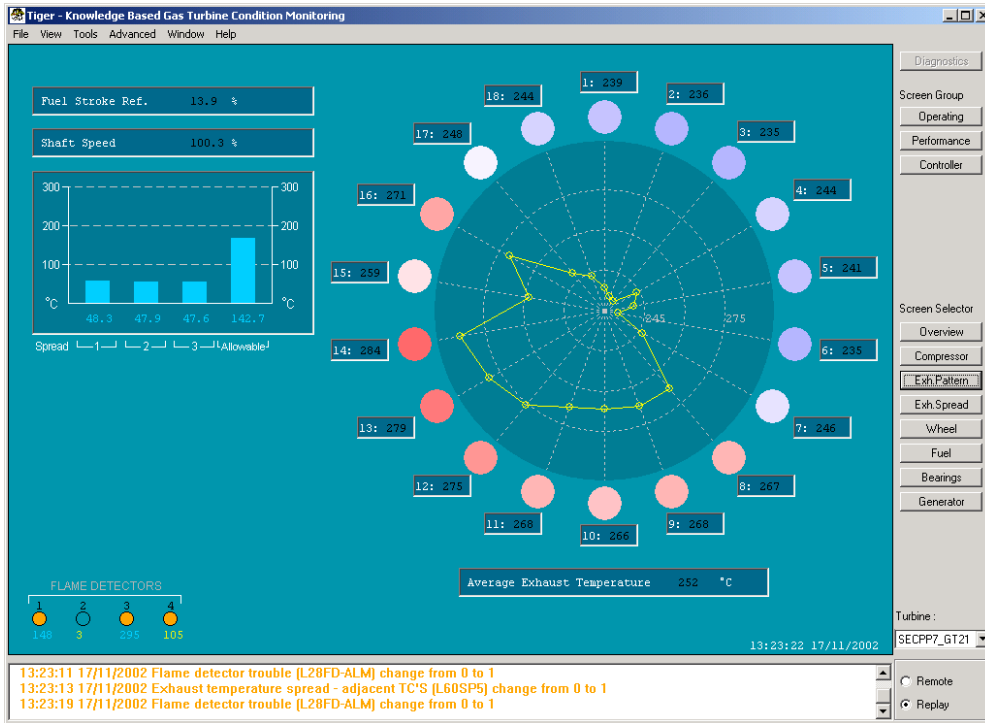
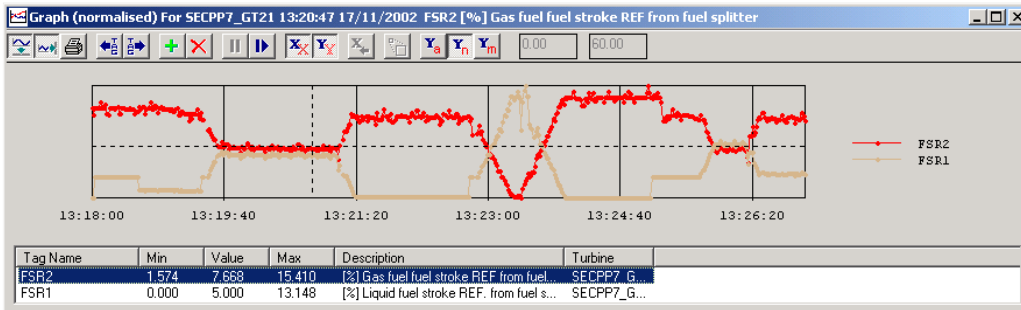
22.	LIQUID FUEL PROBLEMS DURING FUEL TRANSFER	<p>There is a major spike in the flow, followed by smaller transients. These are not in response to fuel demand. This may indicate problems in the liquid fuel system. The subsequent fuel transfer is successful, however as can be seen from the spread screen, the combustion on liquid fuel is poor, with an increase in spreads and a flame out indicated on one can. Based on this, It is possible that a liquid fuel startup or prolonged liquid fuel operation would fail</p>	<p>Check and overhaul the liquid fuel system as needed.</p>

This fuel transfer appeared to be a test carried out a full speed no load. During this fuel transfer, TIGER detects erratic fuel flow.

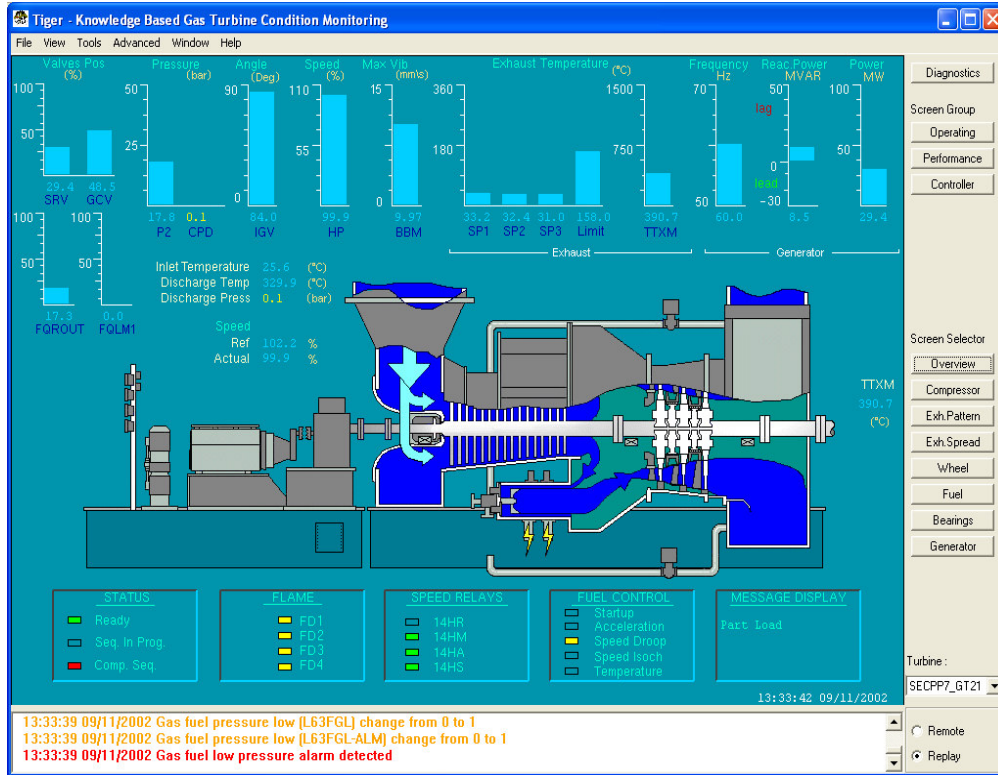
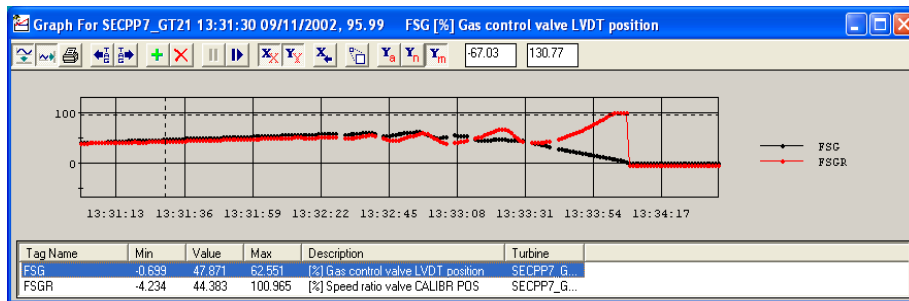
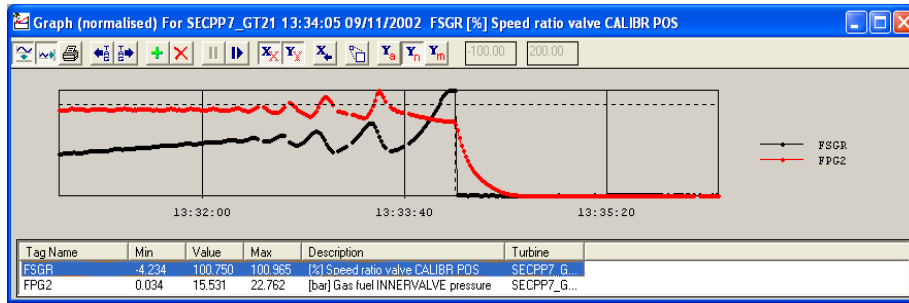
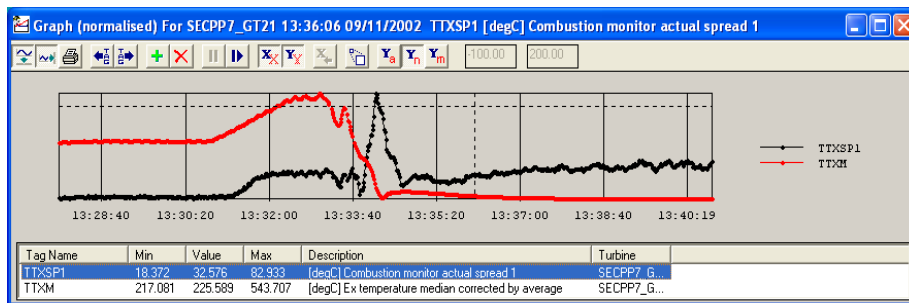
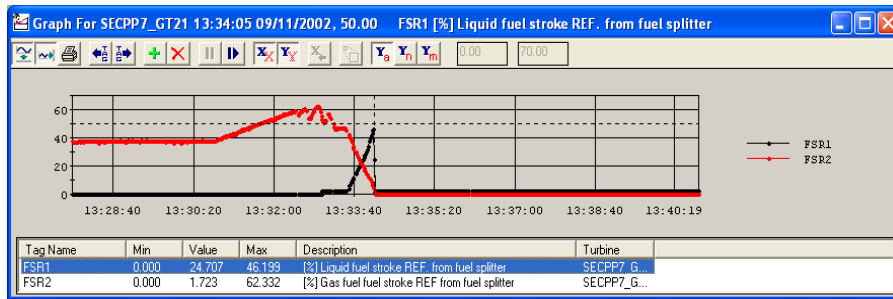
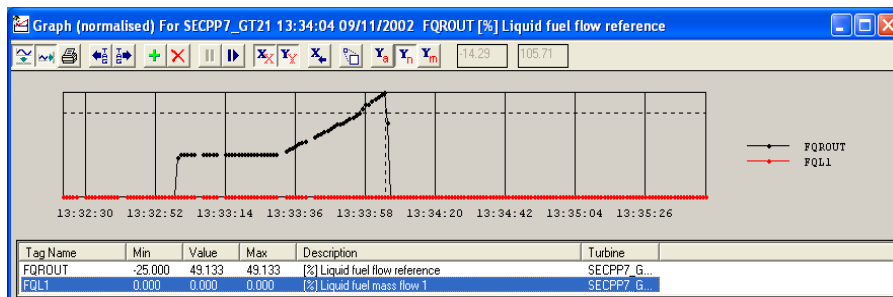
24.	TRIP DUE TO LOW GAS PRESSURE AND NO LIQUID FUEL FLOW	<p>During the fuel transfer there are problems with low and unstable gas fuel pressure. However, critically there is no liquid fuel supply, so the turbine eventually trips on flame out as the gas fuel is reduced but no liquid fuel is supplied to replace it. This was an operational problem, as it appears the manual stop valve for the liquid fuel was off when a fuel transfer was attempted. Hence it failed.</p>	<p>Ensure that all liquid fuel isolation valves are open before attempting a liquid fuel start or gas to liquid fuel transfer.</p>

- 13:32:54 09/11/2002 » Gas fuel low pressure alarm detected
- 13:33:00 09/11/2002 » Liquid fuel flow problem - too low
- 13:33:01 09/11/2002 » Exhaust temperature high alarm detected
- 13:33:15 09/11/2002 » Gas fuel low pressure alarm detected
- 13:33:39 09/11/2002 » Gas fuel low pressure alarm detected
- 13:34:01 09/11/2002 » Gas fuel pressure at low level
- 13:34:06 09/11/2002 » Loss of flame trip

13:33:30 onwards, the Gas Control Valve keeps opening to maintain gas fuel pressure. The Inlet guide vanes are also moving, but TTXM keeps dropping.

Exhaust temperature and spread – spread increases as gas fuel reduces

Controller setpoint request for liquid fuel (FQROUT) – but no liquid fuel flow (FQL1)

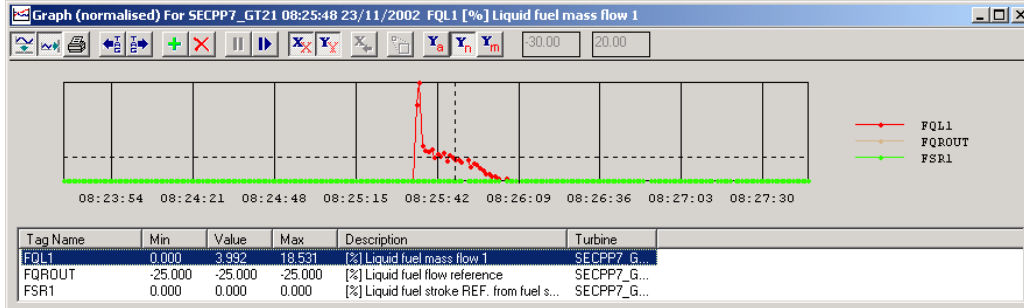
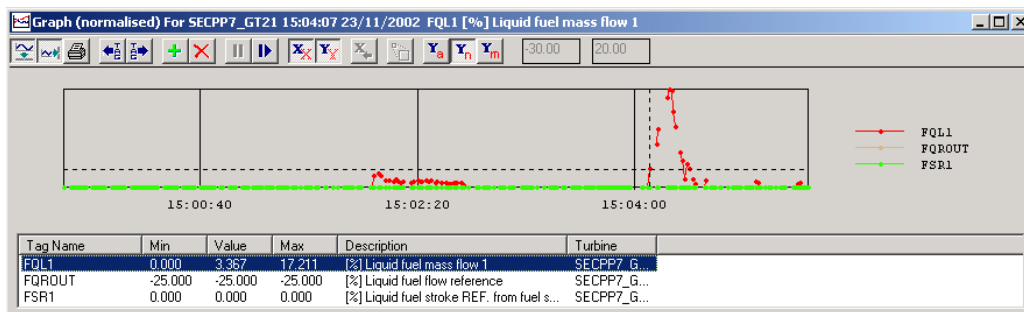
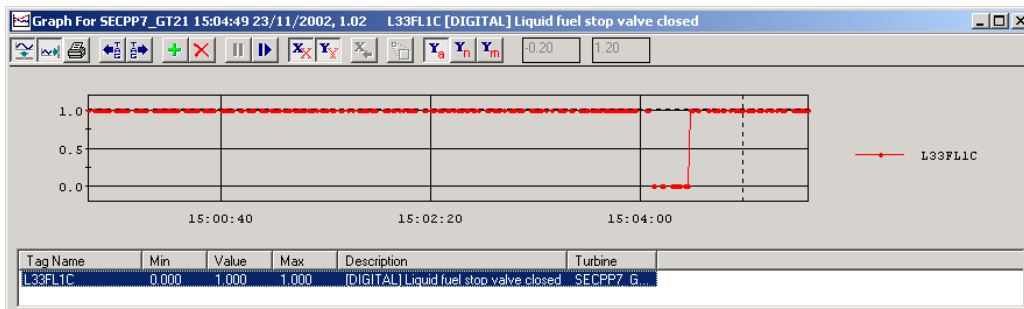
TIGER again detects several controller alarms relating to liquid fuel. However, the turbine is stopped and no liquid fuel has been requested. There appears to be some fuel flow that may be going through a bypass valve. It does appear that a liquid fuel start was attempted, but was locked out due to hydraulic pressure problems or due to high startup fuel flow.

There appears to be some fuel flow that may be going through a bypass valve. Site personel have informed us that this is due to manual priming and purging of the liquid fuel system. This means that the MkV alarms and TIGER diagnostics can be ignored for this situation.

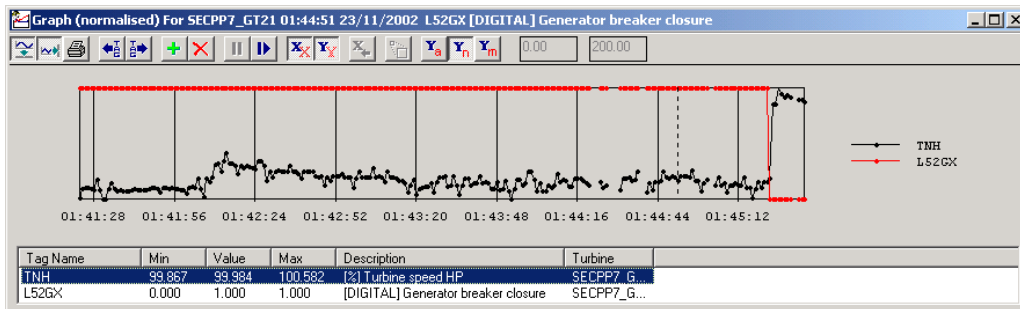
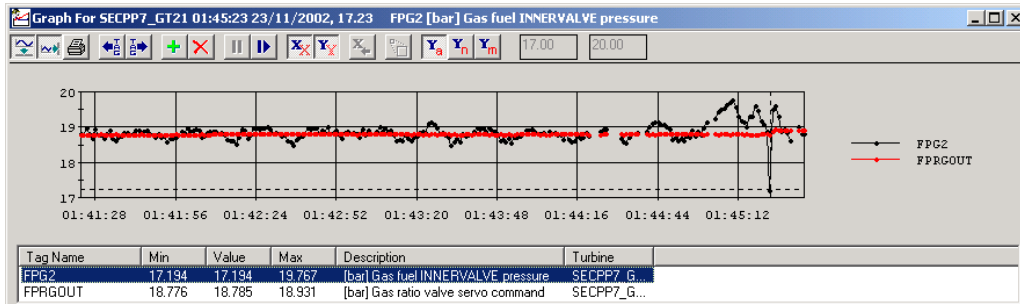
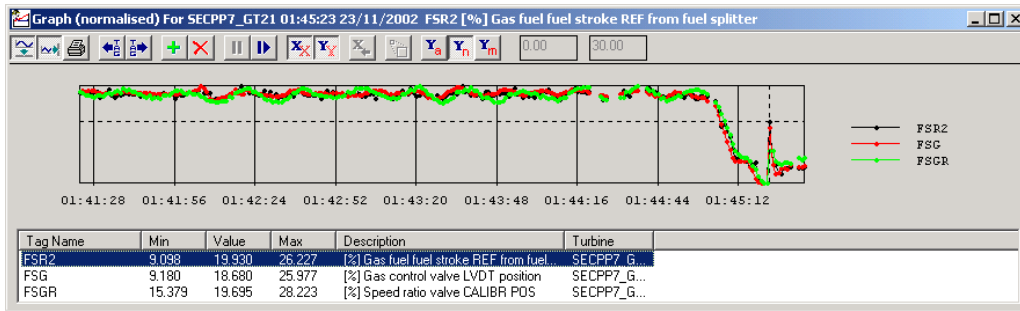
As can be seen from this example, the generator is disconnected from the grid, which causes some turbine instability. However, the response of the two fuel valves fails to maintain a stable P2 pressure. This is not a serious problem, but may indicate sub-optimal performance of the fuel valves, particularly the speed ratio valve. This incident does not appear to be a significant problem. However, the other incidents reported by TIGER diagnostics are.

28.	GAS FUEL P2 PRESSURE INSTABILITY	<p>The generator is disconnected from the grid, which causes some turbine instability. However, the response of the two fuel valves fails to maintain a stable P2 pressure. This is not a serious problem, but may indicate sub-optimal performance of the fuel valves, particularly the speed ratio valve. This incident does not appear to be a significant problem. However, the other incidents reported by TIGER diagnostics are.</p> <p>This is probably related to the control/oscillations problem reported earlier, and is either due to a controller tuning problem or fuel valve problem.</p> <p>There is also a valve overshoot on one of the startups. This also indicates bad control.</p>	When convenient, auto tune the controller and fuel valve system. If this doesn't correct the problem, a manual controller and fuel valve tuning could be done. If this fails, then check the operation of the gas fuel system and the pressure stability of the gas fuel supply. Overhaul and/or replace any worn or faulty fuel valve components as required.

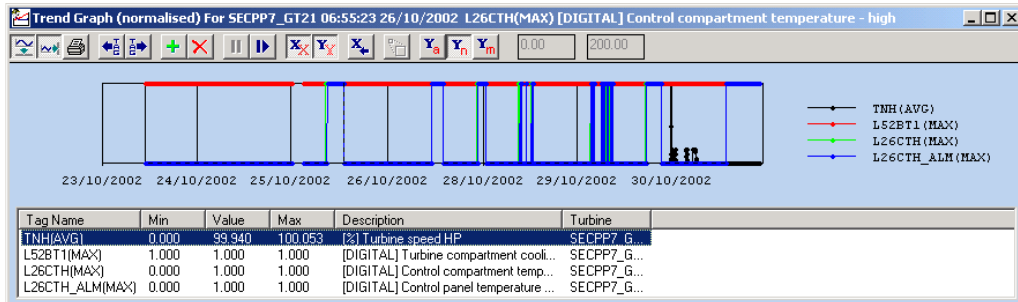
The monthly trend graph for October indicates how the controller compartment temperature alarms are triggered for extended periods. Speed is included to indicate when the turbine is running or stopped.

Turbine compartment cooling fan, controller compartment high temperature alarms and speed.

As can be seen from the two trend graphs, the controller compartment temperature alarm is frequently triggered. This indicates that the compartment temperatures are too high. This may well affect the reliability of the controller, and could lead to faults developing. The two trend graphs also indicate that the compartment fans appear to be running, and the fact the alarms persist for longer during the October period probably indicates that the higher ambient temperatures then are increasing the compartment temperatures above the alarm limit for longer periods.

Check the compartment fans and cooling systems, and repair or upgrade as necessary.

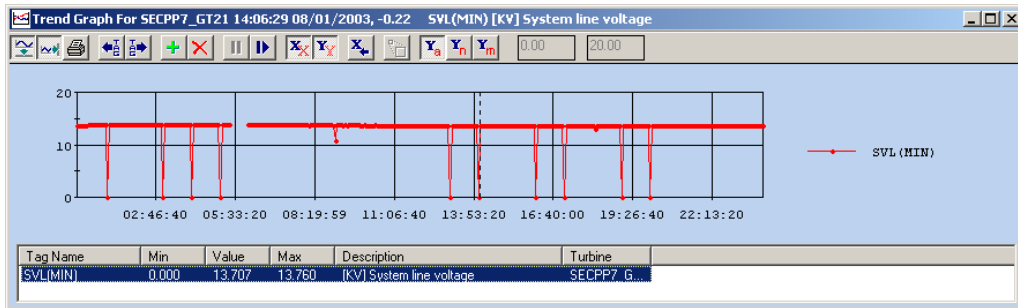
These drop outs are currently occurring frequently, as indicated from the data for the 7th January 2003. The daily trend graph for this day shows the dropouts on the grid voltage and frequency during the day. These dropouts also occur on the generator voltage, but do not occur on the generator frequency, turbine speed or power.

Daily trend - grid voltage.

This is most likely a problem with the grid frequency and voltage sensors or controller operation, as there is no perceived physical effect on turbine operation, i.e. on speed (for frequency) and power (for frequency and voltage). It also seems unlikely that grid voltage and frequency actually drop to zero and back within a few seconds. As these dropouts occur at the same time as the exhaust temperature thermocouple dropouts reported previously, they are probably being caused by the same controller RST dropouts faults.

Check the relevant controller cards and connections and clean the controller boards and housing with compressed air. If necessary, replace any faulty controller processor components.

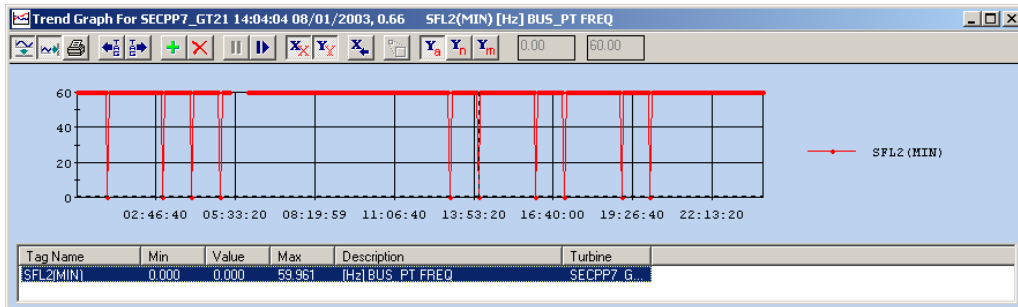
Daily trend - grid frequency.
