Combustion Inspection Elimination Kit

High-tech process to eliminate the requirement for combustion outages between HGP and Major overhauls.

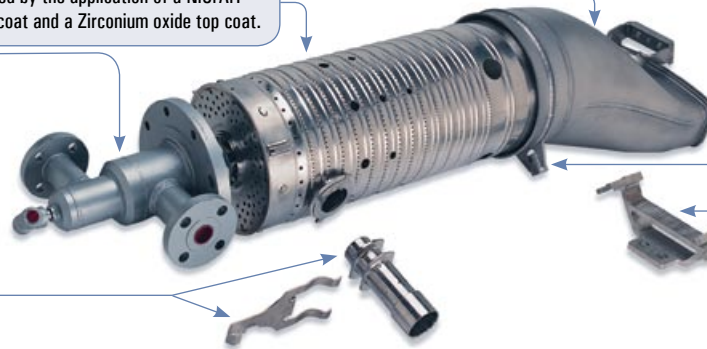
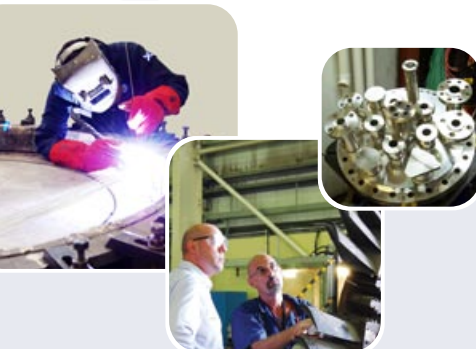
Hastaloy end frames are removed and replaced with frames of Nimonic material in a special welding fixture. U-Section inserts made of a special wear resistant material are welded into the seal groove on the picture frame. New floating seals and a redesigned side seal are supplied as part of the kit.

A wear-resistant coating is applied to the transition piece forward diameter on the mating area with the combustion liner Hula Seal. The aft end is coated with a Zirconium oxide application. (Thermal Barrier Coating).

Wear-resistant material inserts are welded to the existing H-Blocks. These two locations mate with the forward transition piece support bracket (Bull horn support).

The transition piece support fingers are machined back to allow for the installation of a cover of wear resistant material on each of the two arms of the Bull-Horn bracket.
